Prevention of Stress Corrosion Cracking by Shot Peening

By J. H. Milo

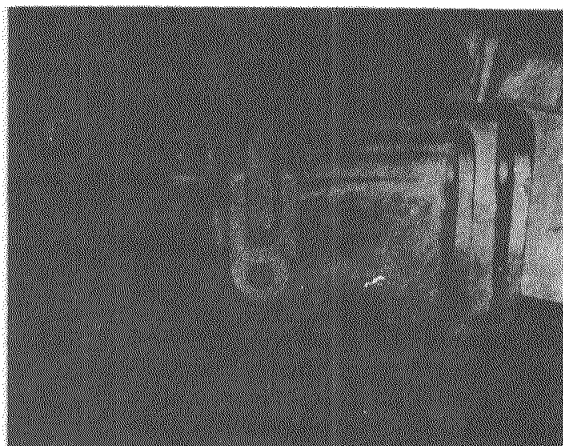
Fig. 1

Main Landing Gear Fitting

After careful review of the fracture, a test, which will be described later, was performed. Following the test, the decision was made to require controlled shot peening through the trunion holes, and on the surface immediately adjacent to them.

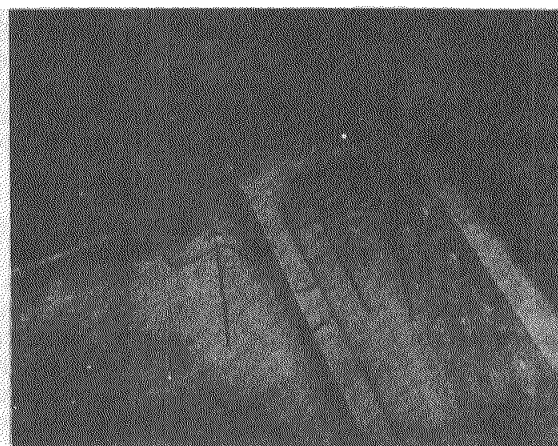
Fig. 2

Location of Failed Area

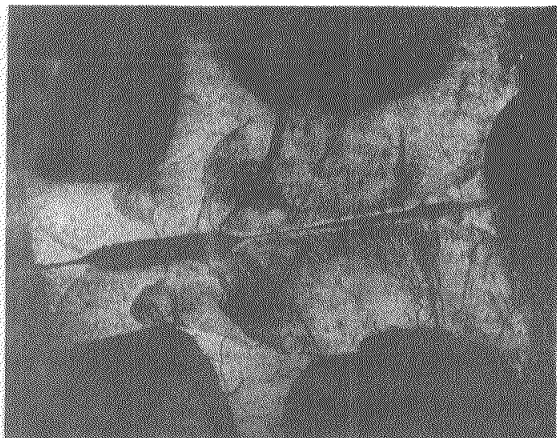
Fig. 3

Opposing Fracture Faces

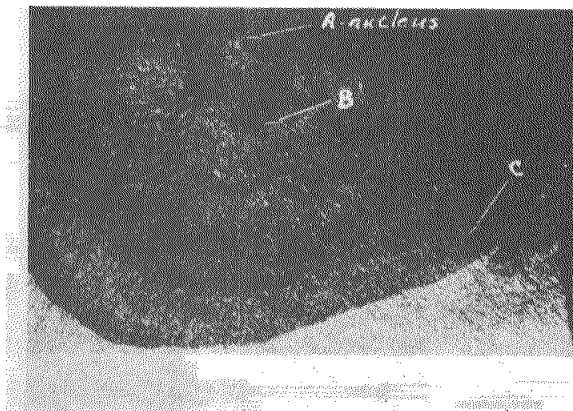
Fig.4

Typical Stress Corrosion Showing Flaky Texture

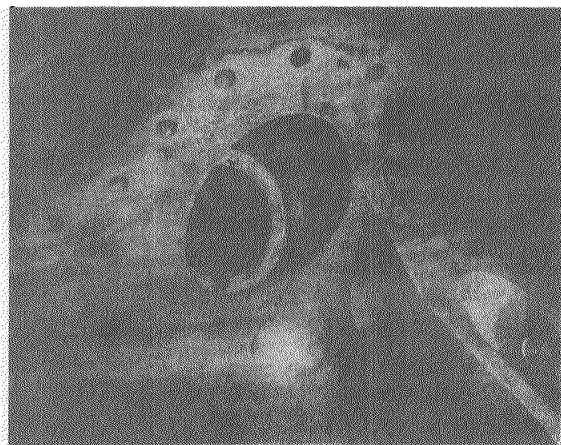
Fig. 5

In the course of an investigation into another problem, the careful inspection of the manufacturer uncovered a crack in another part, in a completely different area (see Figure 5). The crack apparently had two points of origin. This was a rather massive crack extending clear through the section. The fracture surface is shown with the two points indicated as the crack origins, in Figure 6. Following the discovery of the second cracked area, the decision was made to shot peen all surfaces of the finished forging. In addition, forgings already in service were processed in place to avoid a rather difficult and involved removal procedure.

Failed Area Showing Crack

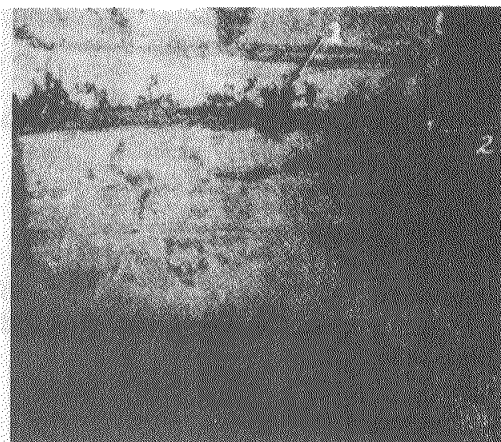
Fig. 6

Two (2) Points Showing Crack Origin

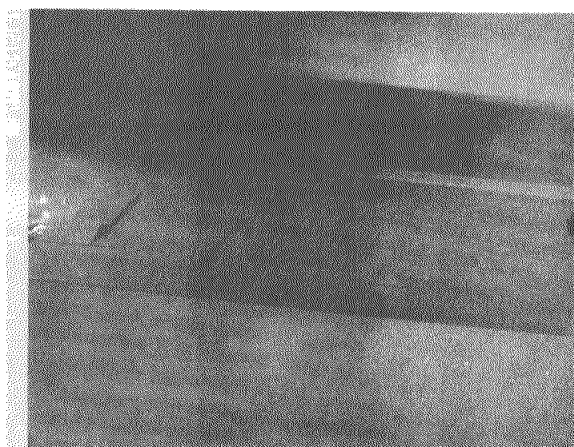
Fig. 7

The part first came to the attention of the Metallurgical Engineering group as the result of a request to evaluate the effects of pitting corrosion that apparently had resulted during anodizing. During the investigation, numerous cracks were noted in the flange. These cracks were closely checked and the decision was made to take a look at some other parts in inventory that were subject to the same processing. An inspection was made of all the parts formed from 7079-T6 in inventory. Many were found to have similarly cracked areas. Figure 7 is a photograph of the side of one of the spars showing some of the cracks. Sections taken through the cracks showed them to be primarily intergranular. This is shown in Figure 8. The photomicrograph was taken at 500 X. Figures 9 and 10 are electron fractographs and were taken at 12,000 X. The first of these shows the brittle, intergranular mode of failure. In the second, the grain boundary oxidation is evident. There was no doubt that these were stress corrosion failures. (It is well to emphasize that these components had never seen service.) The failures were caused by lack of adequate protection during processing and the existence of residual tensile stresses. The cure was a comprehensive program of surface protection during manufacturing processing, plus -- and

Spar Section Showing Crack Areas

this is an important plus -- the addition of shot peening to the processing sequence. Of course, in this and in all other examples cited, the use of shot peening automatically infers the use of adequate controls to insure maximum benefit. As with all tools and processes, shot peening must be properly utilized and properly performed to be beneficial.

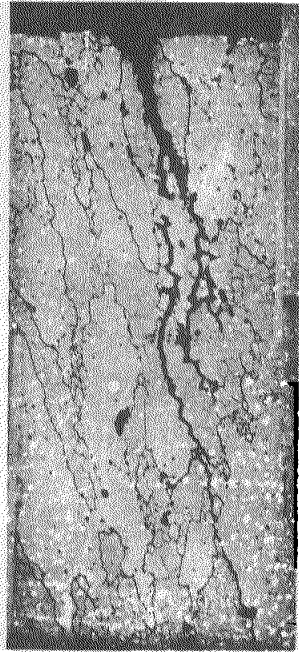
Fig. 8

**Photomicrograph of Crack in 7079
T6 Forging Magnification -500X**

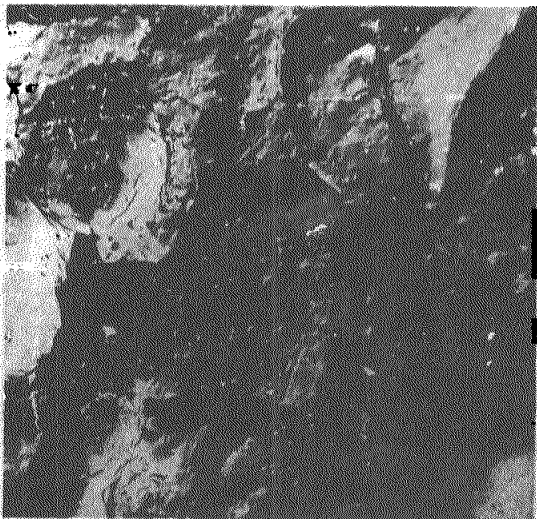
Fig. 9

**Intergranular Type Brittle Failure
12,000X Showing Precipitates**

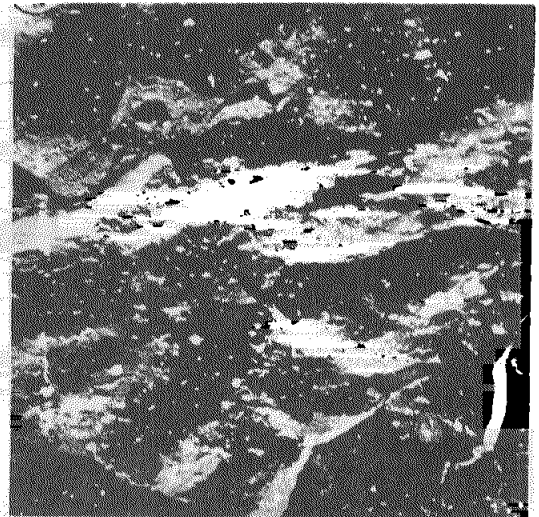
Fig. 10

Grain Boundry Oxidation

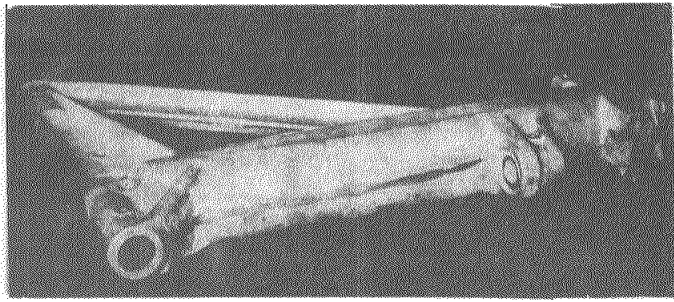
Fig. 11

This next example of the use of shot peening in a stress corrosion application again comes from the aircraft industry. The part in question is the main landing gear cylinder of a small fighter-bomber. It is a forging made from 7075-T6 aluminum. Approximately 100 units from the vendor were put into service with no apparent problems. The next group of parts came from another vendor. The cylinder shown in Figure 11 was removed from service. While sitting on the ground, the cylinder lost its hydraulic capability and the strut went flat. The crack can be seen running the length of the cylinder, and into the trunion hole. Another cylinder was removed from service in the course of a regular maintenance check. The ultrasonic indication is shown in Figure 12. The part was then opened along the fracture line. The crack was shown in Figure 13. Figure 14 is an enlargement of the preceding illustration. This definitely shows the flaky appearance which is characteristic of stress corrosion. The crack origin indicated by the original inspection is at the center of the lower edge of the photograph. Crack location is at the forging parting line. This, of course, puts the short transverse grain structure in the worst possible orientation. Figure 15 is a photograph of a section through the cylinder. The surface was etched to bring out the forging lines. Failure originated in the area indicated by the arrow. Here again, the cure was to shot peen all surfaces. This was approached in steps with the crack moving each time from a peened area to one that had not been specified as requiring peening. There was some serious problems in this instance in connection with the need to maintain accurate dimensions in some of the bored holes. Only through careful control of the peening variables is this possible.

Crack in Cylinder into
Trunion Hole

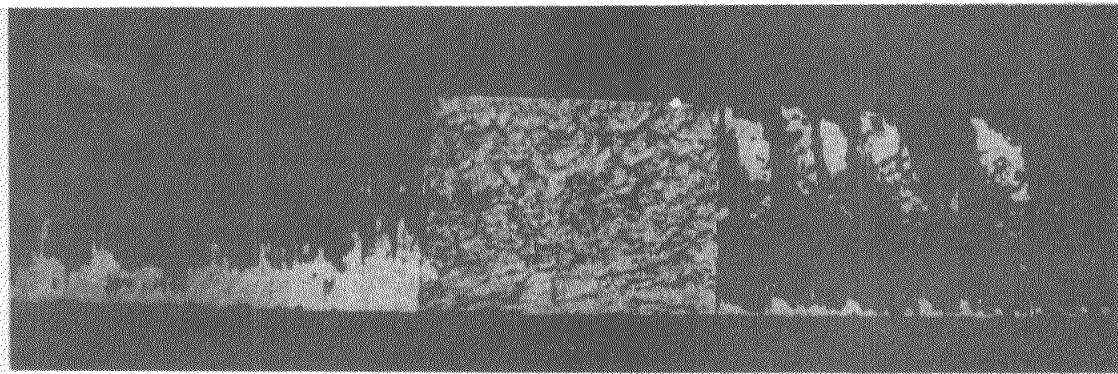
Fig. 13

Defect Surface Showing Fracture Appearance

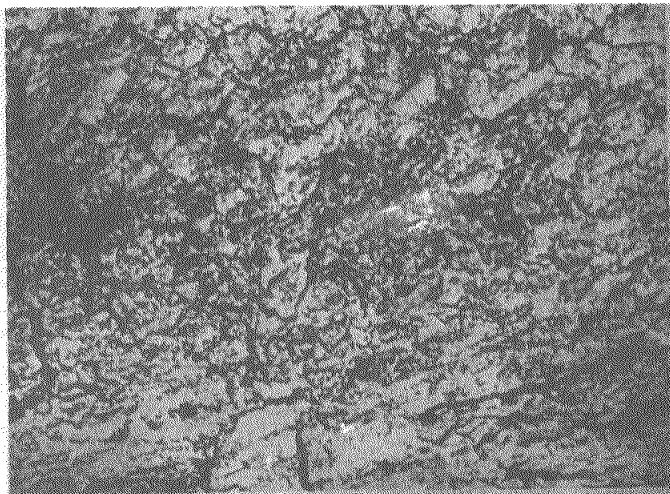
Fig. 14

Enlargement Showing Flaky Appearance
Characteristic of Stress Corrosion

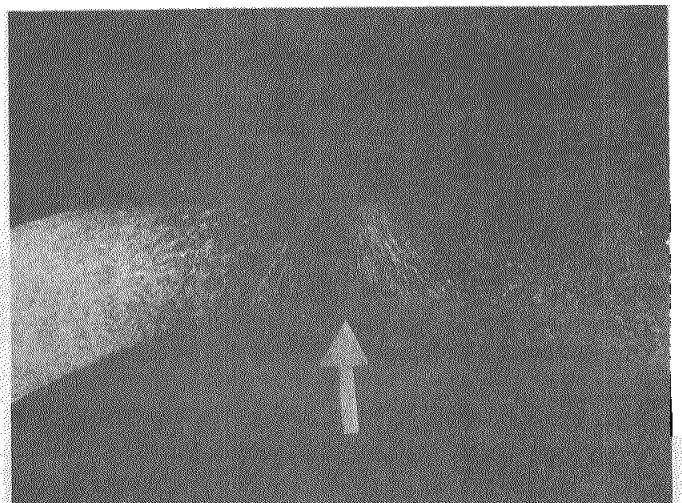
Fig. 15

Etched Surface - Showing
Forging Lines

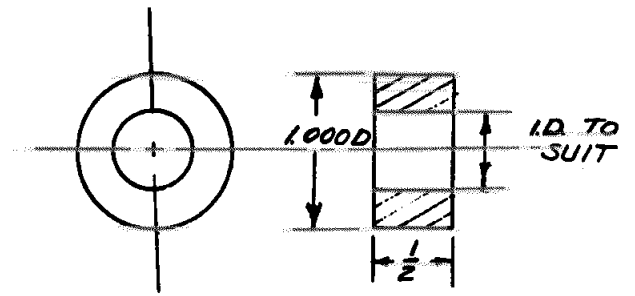
Test Bushings
 Fig. 16

One recent test was performed specifically to evaluate the susceptibility to or the effectiveness in preventing stress corrosion in aluminum bores having steel sleeves. The test parts were constructed as shown in Figure 16. The ring material was 7075 in both the T6 and T73 tempera.

Obviously, the bare material in the T6 condition would not be satisfactory in a stress corrosion application. Protective coatings do little better if for no other reason than their susceptibility to surface damage. Shrink or interference fit made no apparent difference. The only two means that produced immunity to stress corrosion failure were the T73 heat treat, or the use of shot peening. Of course, the T73 temper involves an accompanying loss in strength.

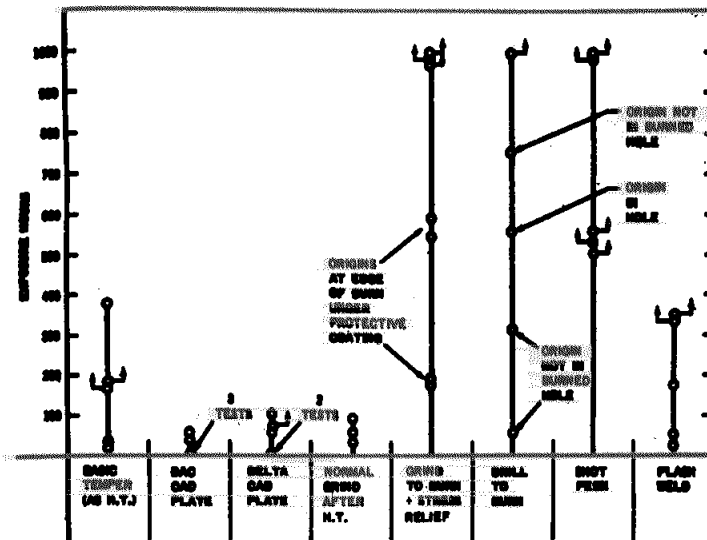
Fig. 17

of the yield strength of the material. Small variations were made in the test specimens for the various test conditions. Included in the test of stress corrosion influences were welding, grinding, drilling, cadmium plating, and shot peening. Residual stress measurements were made on better than 25 percent of the specimens. These were made using X-ray diffraction techniques. The results of this comprehensive examination are shown in Figure 17.

This indicates that only one process produced immunity to stress corrosion. All others experienced some degree of failure. Only shot peening, of all those evaluated, was 100 percent successful. Both the grind to burn and the drill to burn samples indicated some improved resistance from the oxide layer produced by the machining. However, it was only limited improvements.

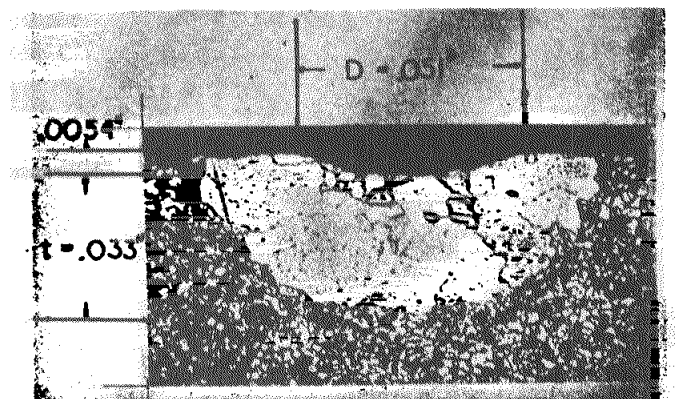
Fig. 21

cross section of the thinnest section, nor should the layer be too thin for it could corrode or wear away thereby negating the benefits of peening." For illustration, let us look at the photomicrograph shown in Figure 21. This shows a single dimple indentation such as you might get from one piece of shot impacting a metal surface. The metal was then heat treated to promote grain growth in the section affected by the cold work. It also provides a representative picture of the typical stress pattern. Let us say that the large grain portray the compressive zone. From the previous figure, we know that immediately below this is a tensile layer. Picture a group of dimples close together providing an even compressive layer. If we then come to an area that has no dimples or dimples that are of lower intensity, the surface stress will either be a lower compressive or a tensile stress. This then leaves the material wide open to attack by stress corrosion. Peening

Photomicrograph of Grain Growth
Under Single Indentation
