METAL IMPROVEMENT COMPANY

## Shot Peening Prevents Stress Cracking in Aircraft Equipment

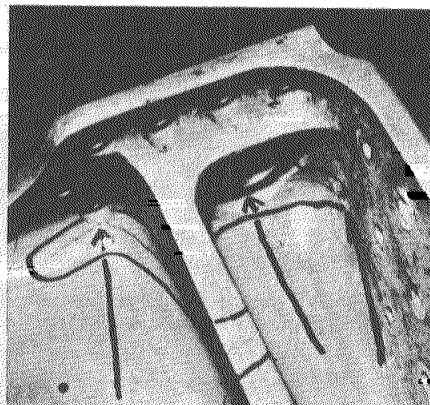
Figure 1—The original failure of the forging in the main landing gear fitting appeared as a crack starting in a trunion hole into which a bushing is pressed. The corrosion did not appear for approximately 15,000 hours.

T6 condition. Original failure appeared as a crack starting in a trunion hole into which a bushing is pressed. The opposing fracture faces are shown in Figure 2. Three areas were chosen for subsequent examination with an electron microscope.

the decision was made to require controlled shot peening on all new parts before putting them in service.

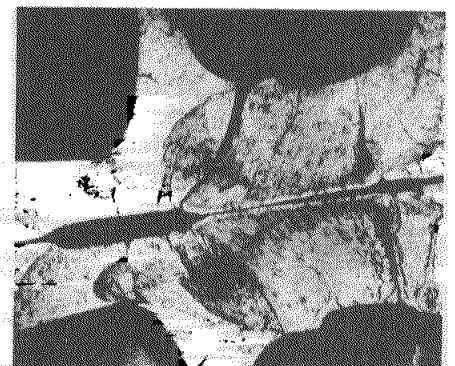
The first two showed clearly the brittle intercrystalline mode of failure with ready evidence of corrosion products. The third area was one of transition from brittle to ductile failure. A survey of the area near the failure point showed many other sources of

Figure 2—Opposing fracture faces of the corroded aluminum forging.

stress corrosion cracks. The failure could have originated from any of several points.

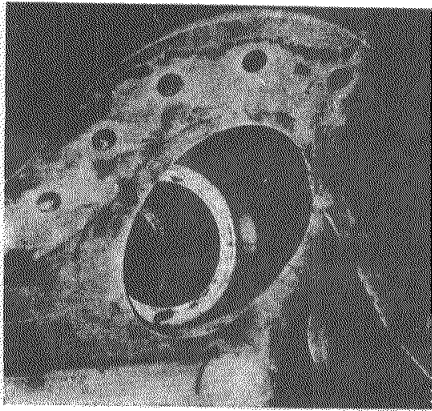
Figure 3—This massive crack, which seems to have two origins, extended completely through the forging.

While investigating another problem, careful inspection uncovered a crack in a different area (see Figure 3). The massive crack, extending completely through the section, apparently had two points of origin. Following the discovery the decision was made to shot peen all surfaces of finished forgings. In addition, forgings already in service were shot peened in place to avoid a difficult and involved removal procedure.

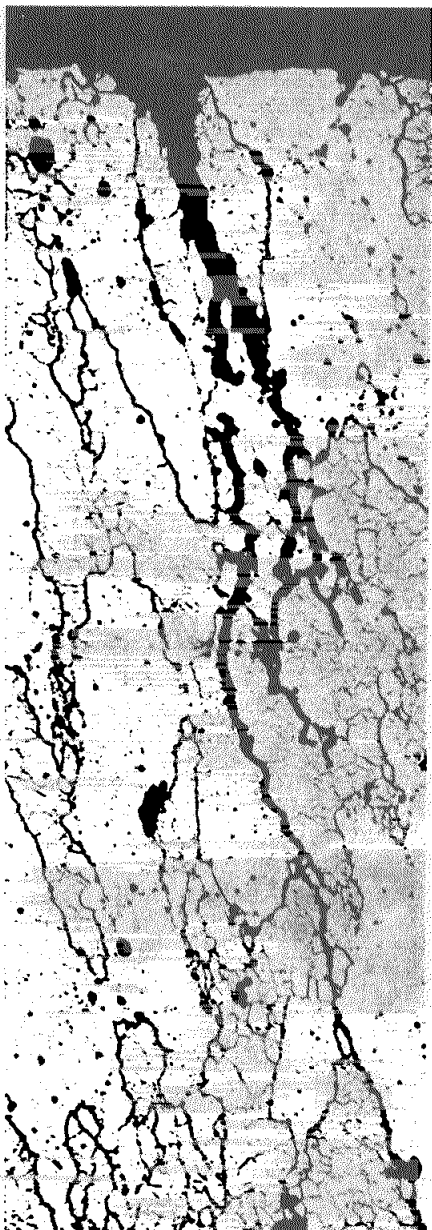
Figure 4—Photomicrograph of a crack found in the 7079-T6 forging. 500X.

This wing spar first came to the attention of the metallurgical engineering group as the result of a request to evaluate the effects of pitting corrosion that apparently had occurred during anodizing. During the investigation, numerous cracks were noted in the flange. These cracks were closely checked and the decision was made to check other parts subject to the same processing. An inspection was made of all the parts formed from 7079-T6. Many were found to have similarly cracked areas. Sections taken through the cracks showed them to be primarily intergranular. This is shown in Figure 4.

The failures were caused by lack of adequate protection during processing and the existence of residual tensile stresses. The method was a comprehensive program of surface protection during manufacturing processing and the shot peening. Of course, in this and in all other examples cited, the use of shot peening automatically infers the use of adequate controls to insure maximum benefit.

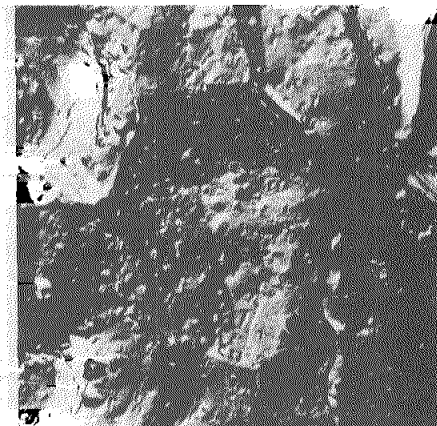
Figures 5 and 6 are electron fractographs. The first of these shows the brittle, intergranular mode of failure. In the second, grain boundary oxidation is evident. Undoubtedly these were stress corrosion failures. (It is well to emphasize that these components had never seen service).

Figure 5—Electron fractograph showing the intergranular type brittle failure. 12,000X.

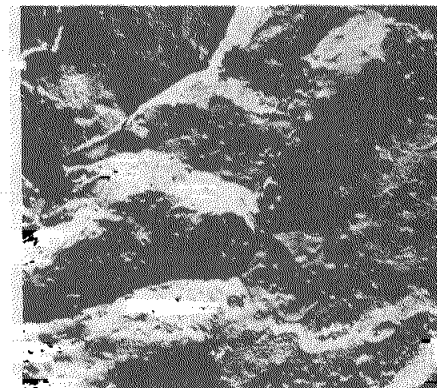
Figure 6—Electron fractograph showing grain boundary oxidation. 12,000X.

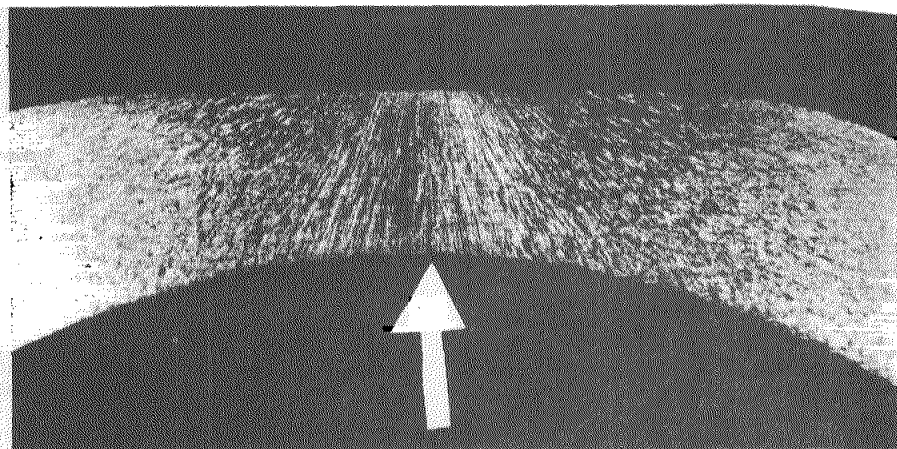
The cylinder was removed from service. While on the ground, the cylinder lost its hydraulic capability and the strut flattened. A crack could be seen running the length of the cylinder and into the trunion hole. Another cylinder was removed from service in the course of a regular maintenance check. Crack location is at the forging parting line, which puts the short transverse grain structure in the worst possible orientation.

Figure 7 is a photograph of a section through the cylinder. The surface was etched to bring out the forging lines; failure originated in the area indicated by the arrow. Here again, the method was to shot peen all surfaces. This was approached in steps, with the crack moving each time from a peened area to one that had not been specified as requiring peening. There were serious problems in maintaining accurate dimensions in some of the bored holes. Only through careful control of the peening variables was this possible.

Figure 7—The corroded surface was etched to bring out the forging lines. Failure originated in the area indicated by the arrow. The surface was shot peened.

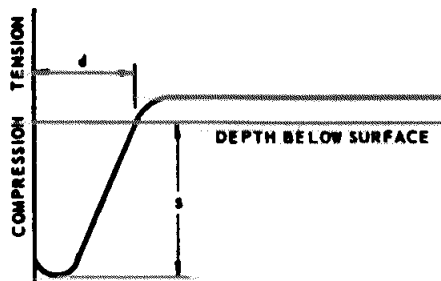
Figure 8—Typical stress pattern produced by peening. There is a high compressive stress at the peened surface, increasing slightly just below the surface.

peening (Figure 8). There is a high compressive stress at the peened surface, increasing slightly just below the surface.

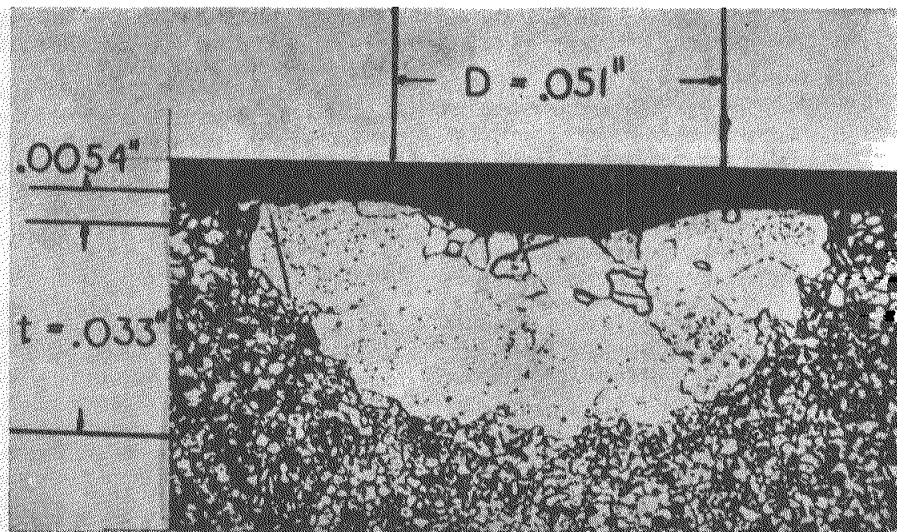
Figure 9—Photomicrograph showing a single dimple indentation that might result from one piece of shot impacting a metal surface.

A group of dimples close together provide an even compressive layer. If an area has no dimples (or dimples that are of lower intensity), the surface stress will either be a lower compressive or a tensile stress. This then leaves the material vulnerable to stress corrosion.
