**DEPARTMENT OF THE NAVY
NAVAL AIR DEVELOPMENT CENTER
JOHNSVILLE
WARMINSTER, PA. 18974**

Report No. NADC-MA-7061

① **EXAMINATION OF AN F8 AIRCRAFT MLG SHOCK
STRUT P/N 548100-521 FAILURE.**

ANALYTICAL REWORK PROGRAM, WORK REQUEST 1-5060

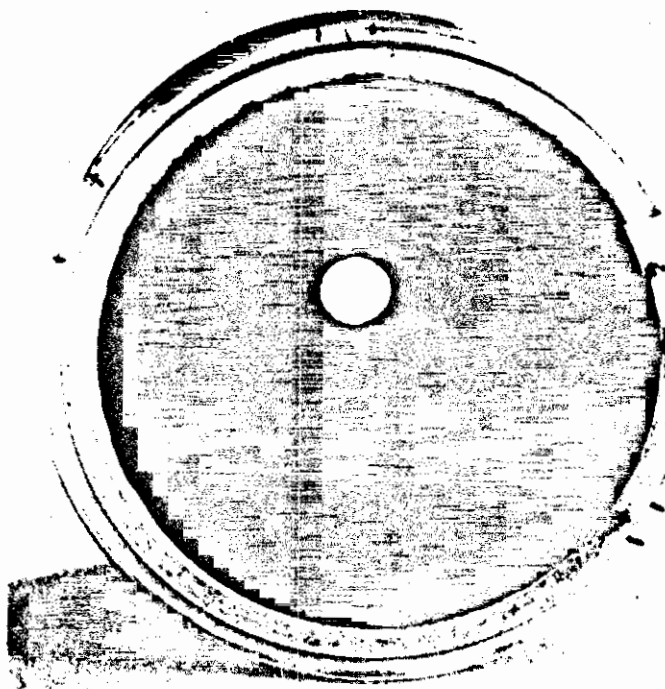
First, visually and optically assisted examinations were made on the fracture face of the failed part. Beginning with the beach marks at the outer periphery, the fracture face was very uniform around the entire circumference of its outer edge, see Figure 1. Some brinelling (pressure burnishing), was most apparent in the areas next to the shear-lip along the inner circumference. The width of the shear lip, as seen in Figure 1, indicated that the fracture process ended at this general location. The NAVAIREWORKFAC investigation was well advised to take the section shown at 2 o'clock, Figure 1 (and rear right, Figure 2), for its metallographic examination. Figure 2 shows that the failure occurred in the 0.060" radius of the peripheral groove adjacent to the filleted land in the chrome plate run-out area. The land seems to have been the main target for the rework shot-peening. A closer investigation of the outer edge of the fracture face revealed that in addition to the brinelled facets, certain indentations existed in fracture lip, see Figure 3. For want of a better designation, these have been called "cleavage steps" for the purposes of this report. They can be distinguished from the brinelling because, although they showed the same beach mark pattern, the plane of failure was below the main fracture surface, which they joined by means of the "cleavage step." Hairline cracks, very difficult to observe or even to photograph, were found scattered in the shot peened surface of the groove containing the fracture plane. Figure 4 illustrates the condition of the fracture surface in the vicinity of the widest part of the shear lip at the inner diameter. Figures 3 and 4 are from fracture surfaces 90°, designated as areas A and B, respectively. Note the remarkable continuity of the beach marks.

Fig. 1 - Plan View of As-Received Failed Piston

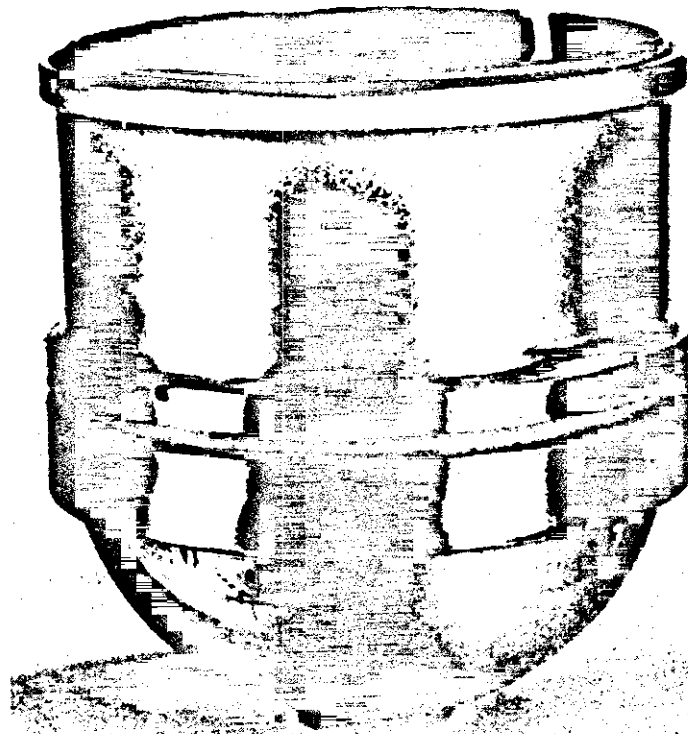
Fig. 2 - Elevation View of As-Received Failed Piston

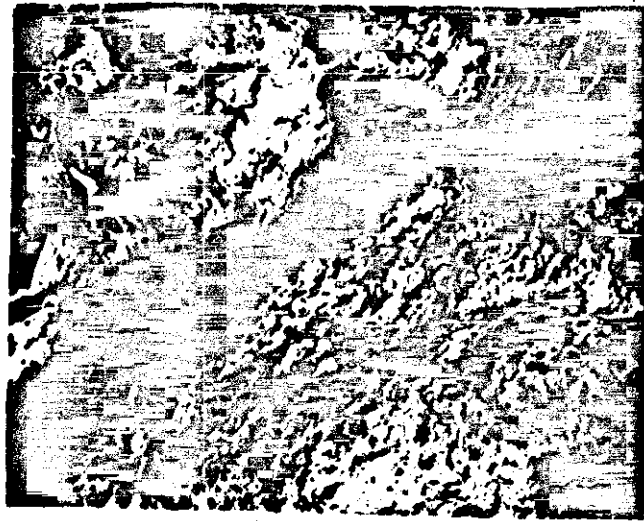
Although several areas of the fracture surface were replicated and examined with the electron microscope, only those most representative of the fracture topology in areas A and B are given in Figures 5-8 (Area A) and Figures 9-12 (Area B). Figure 5, for instance, shows the obscuring effect of corrosion which may have masked fatigue indications, more clearly shown in Figure 6, found in the fracture lip edge of Area A. Similarly, Figure 9 shows the fatigue mode of failure at the fracture lip edge in Area B. Figures 7 and 10 show a mixture of dimpling and intergranular modes characteristic of shear failures in 7075-T6 aluminum alloys. They are representative of the fracture topology found in the central part of the fracture surface seen in both the A and B areas viewed macroscopically in Figures 3 and 4. Figure 11 is an additional fractograph showing an intergranular mode of failure in the central fracture topology found in Area B. Figures 8 and 12, fractographs of the inner wall surfaces adjacent the inner fracture lip of Areas A and B, respectively, show patches of intergranular penetration in the mechanically deformed inner wall of the failed piston.

Fig. 5 - Electron Fractograph - Outside lip edge, corrosion masking fatigue, Area A.

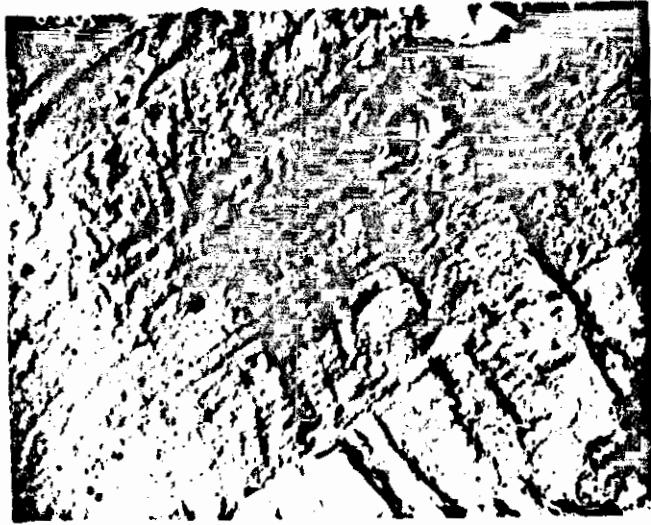
Fig. 9 - Electron Fractograph - Outside lip,
Area B

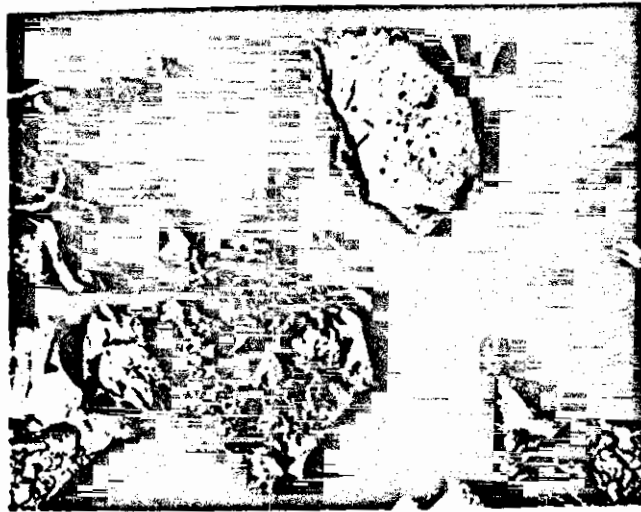
Fig. 10 - Electron Fractograph - Middle cross-section,
Area B

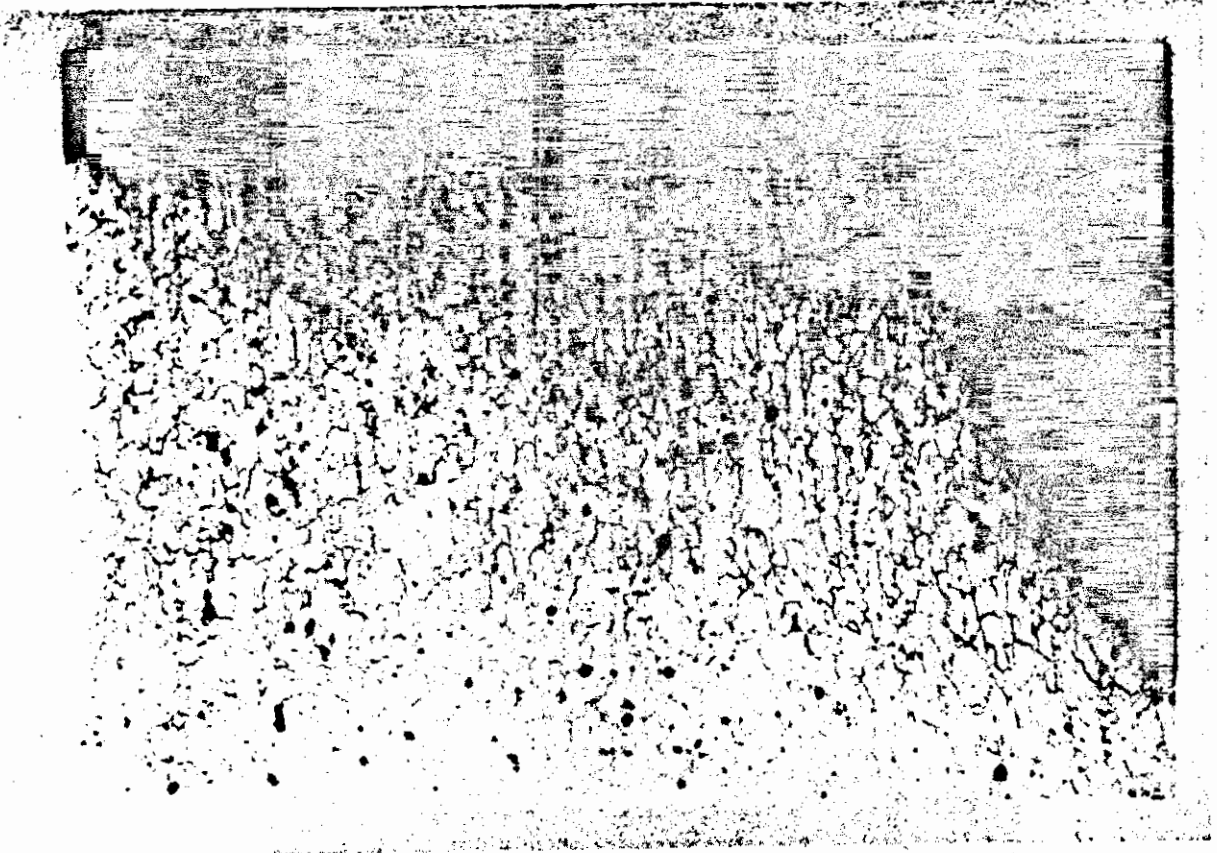
Cumulative cyclic stress damage would extend initial cracks in the groove base until they were linked in a common plane of failure perpendicular to the acting tensile stresses. At the visual level, continued cyclic loading would produce the beach marks found in both the main fracture surface and in the base of the "cleavage steps" prior to the catastrophic final failure of the part. That this in fact is what occurred can be seen in the photomicrographs of Figures 1, 2, 3, and 4 as well as in the photomicrographs showing the fracture profile as shown in Figures 13, 14, and 15.

Fig. 13 - Photomicrograph (100X), etched
Fracture profile; shot peened groove.

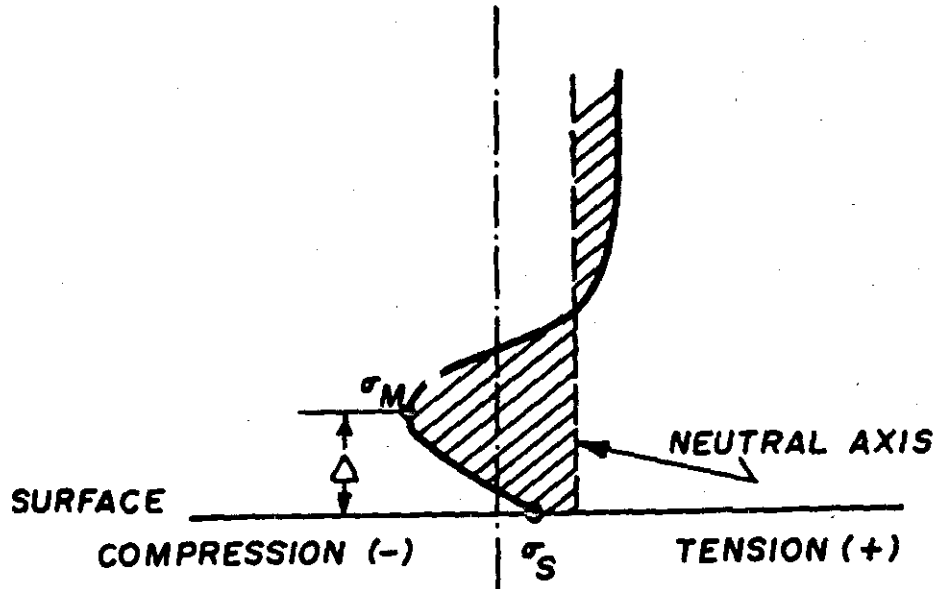
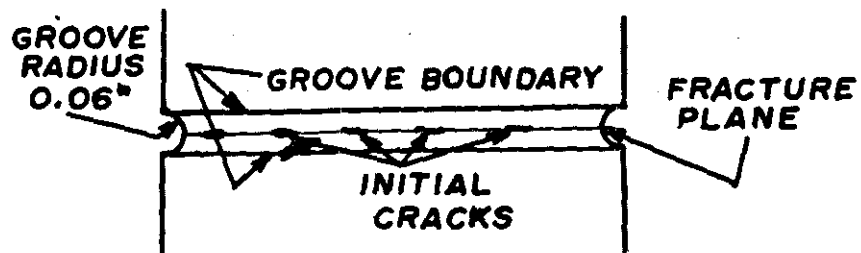
FIGURE 16 - SKETCHES OF SHOT-PEENED PART.

the metal below this deformed layer is not plastically deformed, this surface layer is placed in residual compression after the shot peening process is completed. A schematic representation of the residual stress situation in the part at this stage is presented in Figure 16 (a). Of course, the actual residual stress conditions produced in any particular part will depend on a variety of factors. These include part design and material as well as the controllable parameters of the shot peening process itself: the shot material, its size and hardness, "exposure time" and "exposure velocity." These should be specified and controlled for the particular application. No facts have been developed that indicated, that for the failed piston, any control of the shot peening process was in effect during its rework.

To explain the observed fatigue failure mode in the failed part, the effects of a cyclic tensile load superimposed on the residual stresses also should be considered. Referring to Figure 16 (a), for conditions prior to loading, the shot peened part would have a surface residual compressive stress, designated σ_s . As shown, it is less in absolute value than the maximum residual compressive stress, σ_{max} , lying to a depth Δ below the surface. In a real situation, especially if an improper selection of shot peening control parameters had been made, residual stress conditions could have been induced in the part so as to leave the surface, and for a small distance below, in tension while allowing a maximum compressive stress near but not at the surface. A similar situation could be caused also by the superposition of a tensile load effect on the conditions represented by the sketch. That is, if a tensile load were superimposed, the neutral axis (the boundary between the tensile and compressive residual stress fields as depicted in Figure 16 (a)) would be displaced. Unloading would return it to its original position. Cyclic loading would thus mean that for every cycle the surface of the part would be in tension for a finite time. Since a tensile stress is one requirement for the initiation of stress corrosion, corrosion-fatigue, and fatigue modes of failure, it can be readily understood how, despite shot peening, failure can originate. Therefore, it cannot be inferred that shot peening would keep a surface from encountering tensile stress conditions in service. Shot peening only reduces the vulnerability of a part to fatigue and corrosion effects but does not eliminate their possibility. It does, however, maintain surface tensile stresses at a lower level than otherwise would be the case. As to whether or not "shot peening may have contributed to premature failure," reference (b), the answer requires better information than that so far available concerning the details of the shot peening process used and the service history available for the part.

A crack having been initiated in a shot peened surface would tend to penetrate the part in a direction perpendicular to the applied tensile load, see Figure 16 (b). On encountering a compressive stress field, the crack tip would be blunted or would branch, tending to extend laterally. A crack growing in such a manner would exhibit in cross-
