Failure Investigation of Large Wind Turbine Transmission Housings

by Peter C. Riccardella, George J. Licina, Darryl A. Rosario, Richard L. Bax

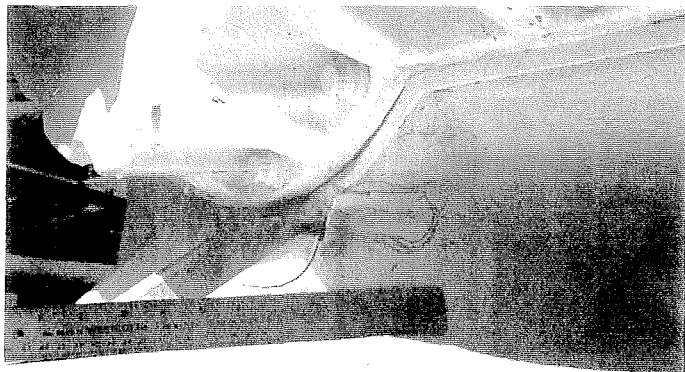
The ductile cast iron transmission housings of the large, 410 KW wind turbines produced by a major U.S. manufacturer were failing at an alarmingly high rate after only short operating periods (one or two wind seasons). As illustrated in Figs. 1 and 2, the failures initiated as corner cracks at a gusseted transition section between the main turbine housing and a heavy base plate used to affix the turbine to the tower. Once initiated, the cracks propagated through the wall of the housing, ultimately leading to leakage of oil from the housing, and necessitating shutdown of the units. The failure investigation described in this paper was performed to identify both short term and long term measures which could be used by a wind field operator who had recently installed over fifty such turbines. At issue was the efficacy of remedies to the problem proposed by the

Figure 1. Photograph of severely cracked transmission housing

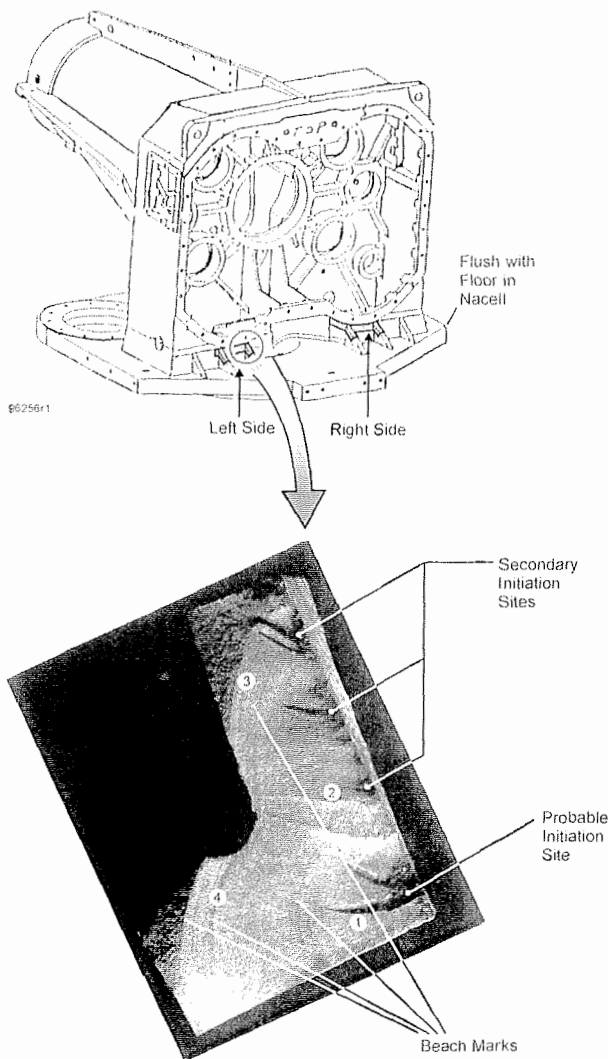
Structural Integrity Associates obtained material from the manufacturer, including specimens containing the more severe cracking, and material from unfailed locations for mechanical properties testing (Figs. 2 and 3). The manufacturer also provided housing design details, which were used to create analytical models (Fig. 4), but very little information was available on the magnitudes of anticipated loads on the housing under various operating conditions. With this as input, the failure investigation proceeded via the following major steps.

Figure 2. Schematic of transmission housing showing location and macrograph of most severe cracking

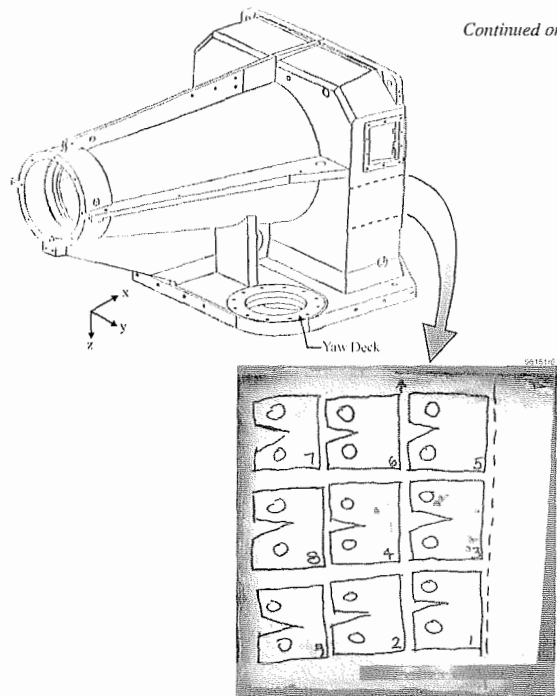
2. Crack Growth Rate Testing – In addition to the field failures, fatigue crack growth specimens were machined (Fig. 3) from the same transmission housing, and tested in the laboratory under controlled loading conditions. The fracture surfaces from these specimens were also examined in the SEM in order to compare the fracture surface characteristics from housing material loaded under unknown conditions (field failures) to those from well-characterized loadings (fatigue crack growth specimens). The objective of this activity was to provide information on the probable time and number of cycles for crack growth and to estimate the stress range that must have existed in the field to produce the observed fatigue failures.

Figure 3. Schematic of transmission housing showing location from which fracture mechanics crack growth specimens were obtained

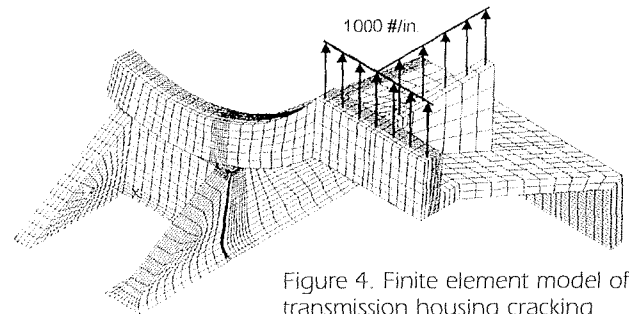
mission housing in the vicinity of the gussets (Fig. 4). The sub-model included only those portions of the housing and adjacent components believed to be of significance to the cracking. A painstakingly detailed mesh was used in the vicinity of potential stress raisers, such as the fillet between the gusset and the housing body (i.e. the crack initiation site). The model was loaded using vertical tractions of 1000 lbs./in. along the top surface of the internal gusset and cover flange, as illustrated in Fig. 4. This loaded region is in the direct load path between the rear, main shaft bearing and the cracking region. Applying loads over this region is considered a reasonable approximation of the wind loading on the housing at the crack location. Since the absolute magnitude and direction of the wind loading were unknown at the time of modeling, an arbitrary value of 1000 lbs./in. upward was assumed as a unit load which could later be scaled up or down as appropriate. The resulting stress distribution is illustrated in Fig. 5.

Figure 4. Finite element model of transmission housing cracking location

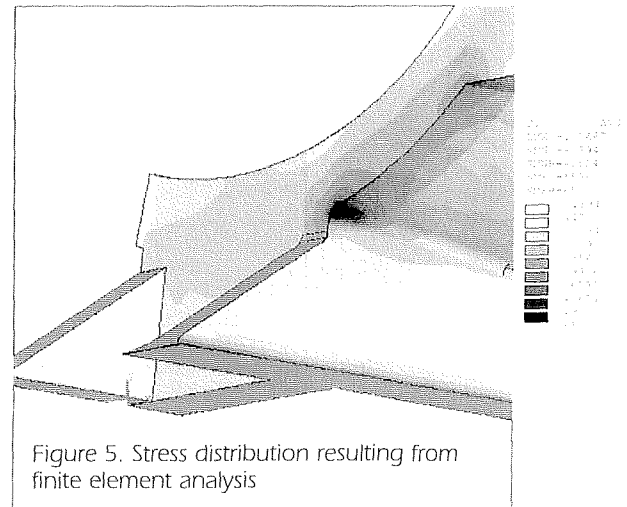
Figure 5. Stress distribution resulting from finite element analysis

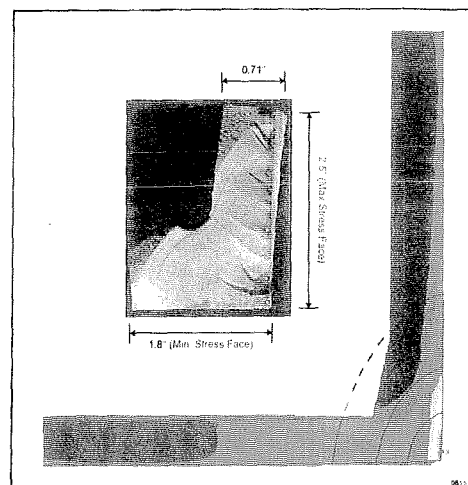
4. Fracture Mechanics Crack Growth and Critical Flaw Size Analysis – As illustrated in Fig. 6, a quarter-elliptical crack was modeled at the highest stressed horizontal section in

Figure 6. Horizontal section of finite element model through crack location with fracture mechanics model superimposed

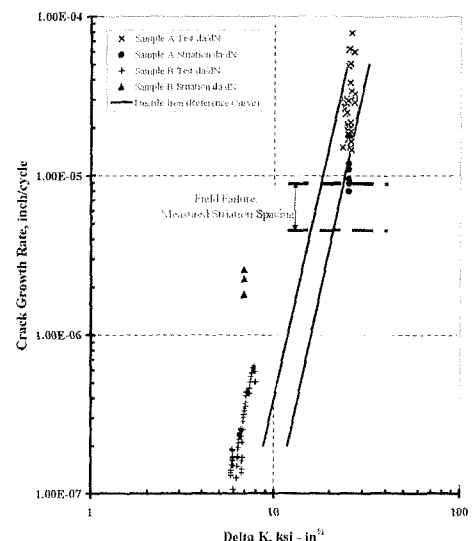
the finite element model in order to predict stress intensity factor versus crack size. The stress intensity range computed in this manner was used as input to a Paris Law crack growth model derived from the fatigue crack growth testing described above, Fig. 7. The computed stress intensity factor range was scaled to a value consistent with the observed crack growth rate / striation spacing in the field failures. This yielded a prediction of the actual load amplitude and number of cycles which must have occurred to produce the observed failures.

Figure 7. Fracture mechanics crack growth test results and correlation with measured striation spacing
