BEWARE THE DODECAHEDRON

A Process is Developed

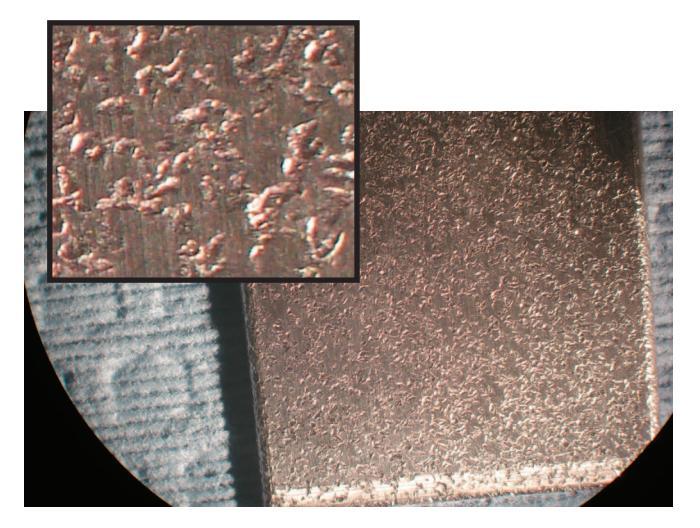
The part coverage and masking on the aluminum part passed inspection. The certification document matched our requirements. Everything was on track until we got to the Almen strips and they looked...weird. Their surface was covered in sharpededged strikes, almost like they had been dented by stabs from a flat-blade screwdriver. We requested a sample of the new shot.

The Almen strip with sharp-edged strikes

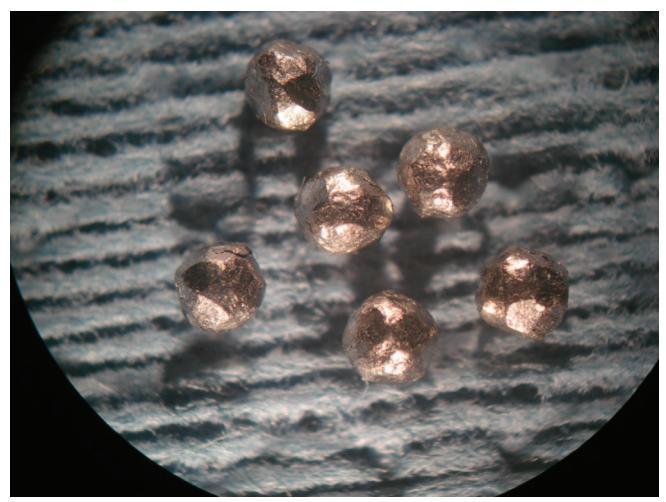
We reviewed the shot per AMS 2430. A 10X microscope with single point lighting revealed a new shape of media we have not seen before. We would describe it as "faceted-gemstonelike." It certainly wasn't the typical spheroid with a slight hint of a barrel shape that we are used to with conditioned cut wire. Also, there were a number of smaller size shot particles and a few flat disc-shaped particles mixed in with the faceted shot. It was difficult to see on the aluminum part; however, that its dents were made by faceted shot.

We think that the media supplier created an aggressive conditioning process that imposed a small number of very hard impacts to each particle, possibly as a quick way of conditioning it into something with a spheroid outline but only if you are willing to ignore the sharp edges where the facets meet. We also have to believe that the media manufacturer unknowingly packaged undersized and disc-shaped particles with their "conditioned cut-wire shot." Most of the undersized shot would eventually be wasted in the screening loop. We're not sure what would happen to the disc-shaped media long term but we don't want to use it to make dents in the short term.

- 1) A faceted gemstone-shaped sharp-edged particle can't make the desired near-spherical dent.
- 2) It's not desirable to make dents with flat disc-shaped media while waiting for the screening loop to remove them.
- The media should have been rejected per AMS 2431/4 Table 2 because it contained more than two (we found eight) unacceptable particles and that's only considering

The faceted gemstone-shaped media

So what can we do to keep poor media from passing inspection, much less entering our shot peening processes? We can improve the intent of AMS 2431/4, AMS 2430 AMS 2431/3 and AMS 2431/8 by adding a new illustration of a partially conditioned particle. For such an illustration, I propose adding a wire frame drawing of a regular dodecahedron and a footnote that references its "facets meeting at sharp edges." Media purchasers, receiving inspectors and shot peening rookies would then be forearmed against the dodecahedron that will harm your shot peening process. The repair station that purchased the unacceptable media certainly could have benefited from additional information. They are new to shot peening and relied on the media's certification. As far as we can tell, they weren't aware of a problem.

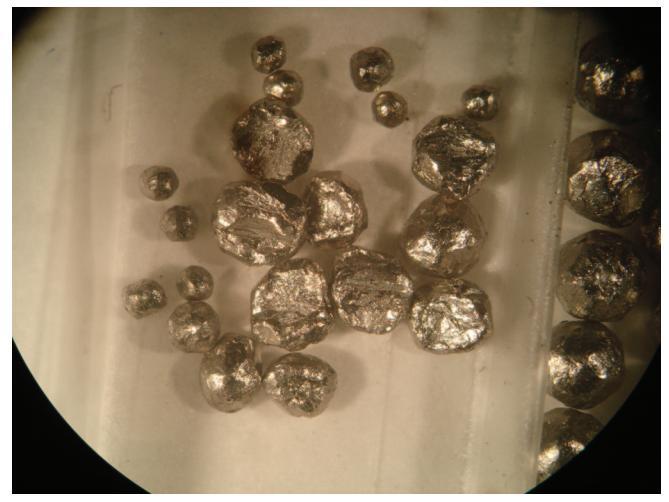
The undersize and disc-shaped media

the flat disc-shaped particles. The small sample size of an ounce allowed only four viewed fields instead of the required nine. (We found 20 unacceptable particles if we include the tiny particles that look like AWS 20 that was mixed in by the media manufacturer.) We were inclined to label the discs and AWS 20 as contamination. Note: The media passed the weight and length requirements if we excluded the discs and AWS 20.
