**Ultrasonic Impact Treatment of Traffic
Signal Mast Arm Welds**

Thesis

Master of Science in Engineering

The University of Texas at Austin

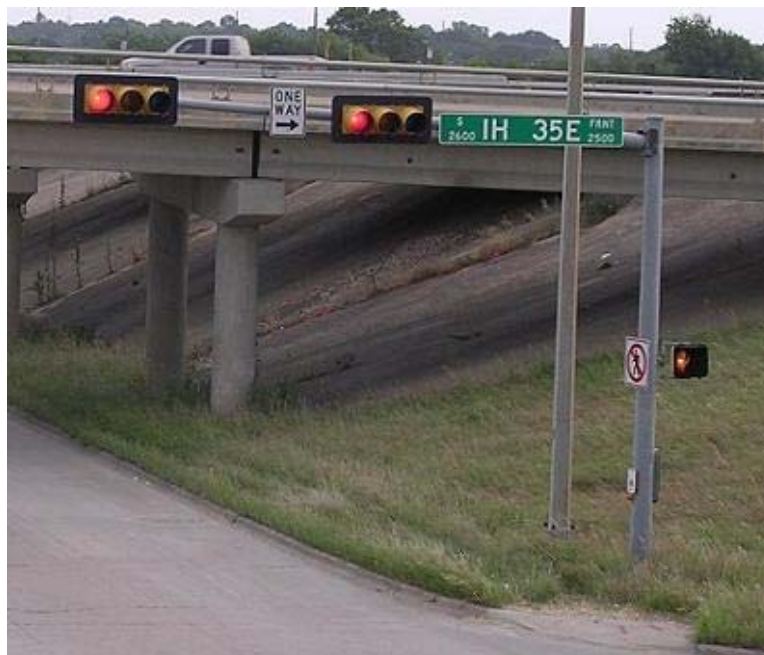
Figure 1.1.1 Typical Cantilever Traffic Signal Structure

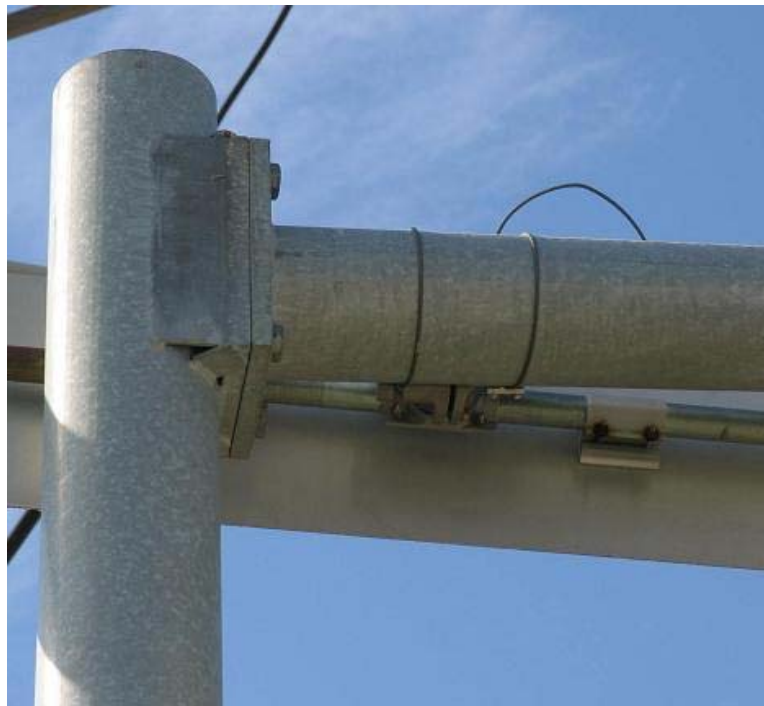
Traffic signal mast arm-base plate connections are particularly susceptible to fatigue [28]. The top of traffic signal mast arm welds experience fluctuating tensile stresses when wind and traffic gust loads cause the mast arm to oscillate, fatiguing the mast arm weld toe [28]. The mast arm fluctuates vertically under wind loads. Horizontal movement from wind loading is minimal [28]. The most common location of fatigue failure on traffic signal structures is the fillet-welded socket connection of the mast arm to the mast arm base plate [28]. The mast arm is welded to the base plate, and the base plate is in turn bolted to a built-up box, which is part of the mast. A typical base plate-to-mast bolted connection is shown in Figure 1.1.2.

Figure 1.1.2 Mast Arm Base Plate-to-Built-up Box Bolted Connection

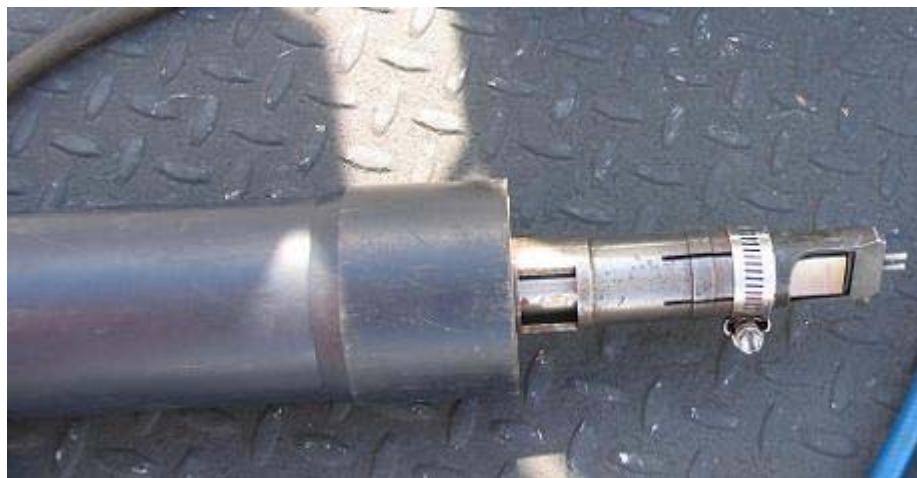
Figure 1.2.1 UIT Multi-Pin Tool With Two 2 mm Diameter Pins

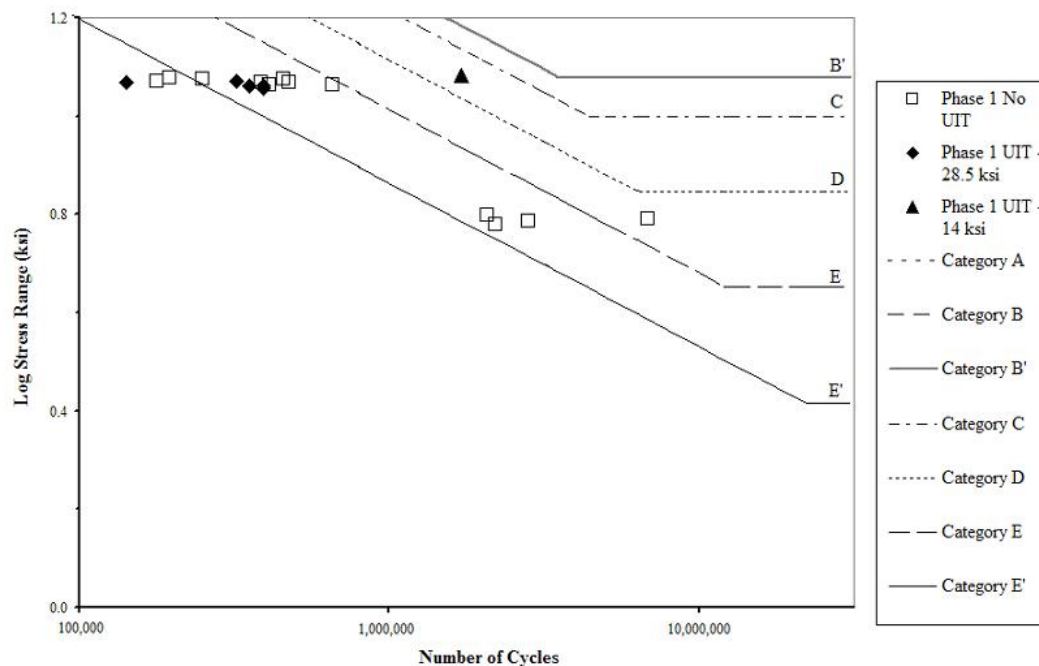
stress of 14 ksi is labeled “Phase 1 UIT – 14 ksi”. Figure 1.2.1.1 shows that the specimen “Phase 1 UIT – 14 ksi” had the greatest improvement in fatigue resistance.

Figure 1.2.1.1 S-N Plot of Koenigs' Phase 1 Mast Arms With and Without UIT

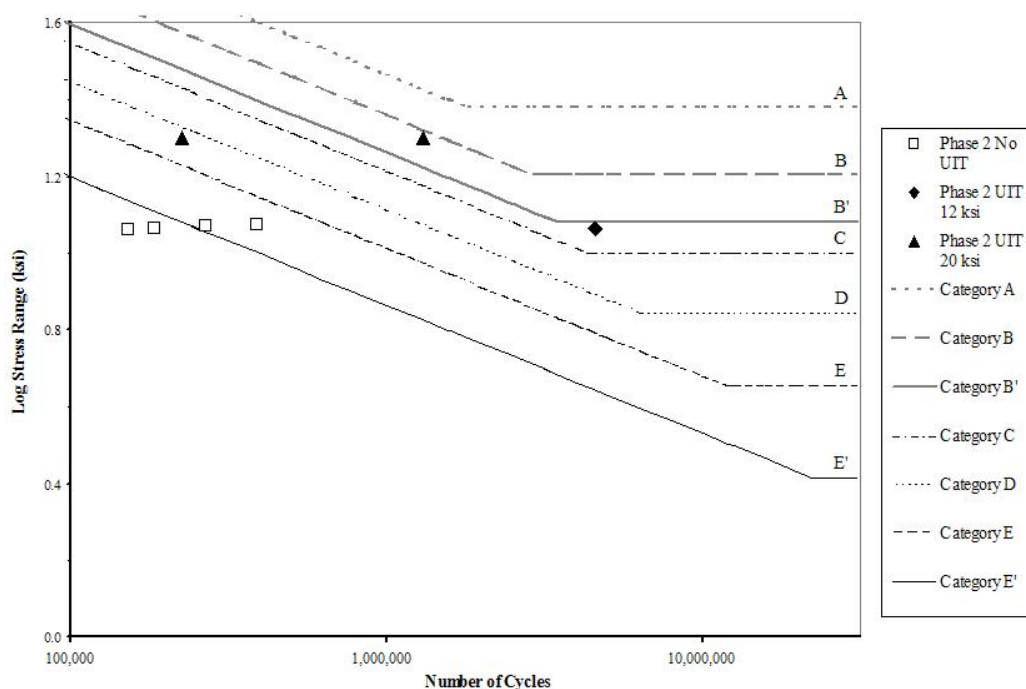
tested at a stress range of 20 ksi are labeled “Phase 2 UIT – 20 ksi”. All fatigue testing in Phase 2 had a maximum stress of 28.5 ksi. Figure 1.2.1.2 shows that mast arms with UIT applied at a 16.5 ksi stress had a significant improvement in fatigue resistance over mast arms with no UIT. The data for tests on mast arms with UIT application before hot-dip galvanization is not included, due to the negative effect that extreme heat has on UIT, which is discussed in Chapter 4.

Figure 1.2.1.2 S-N Plot of Koenigs' Phase 2 Mast Arms With and Without UIT

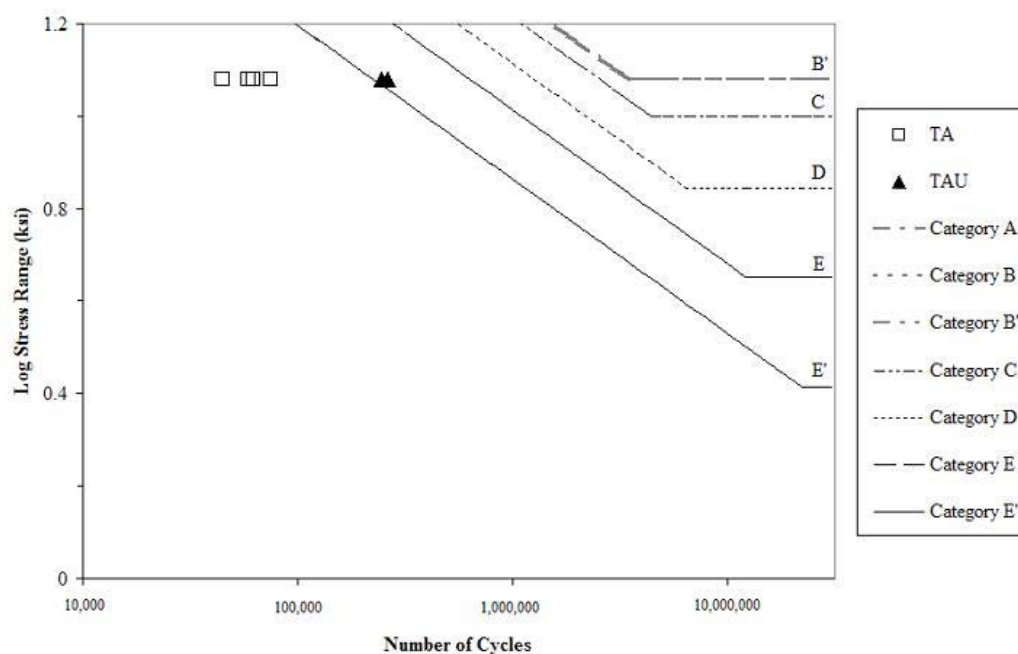
2. Appendix A lists the fatigue results and test conditions of the mast arms from TransAmerican both with and without UIT application. Figure 1.2.1.3 shows the S-N plot of the test results from the TransAmerican mast arms. The mast arms from TransAmerican without UIT are labeled “TA”. The mast arms from TransAmerican with UIT applied under loaded conditions are labeled “TAU”. Figure 1.2.1.3 shows that mast arms with UIT applied under loaded conditions have an increase in fatigue life compared to mast arms with no UIT.

Figure 1.2.1.3 S-N Plot of TransAmerican Mast Arms With and Without UIT

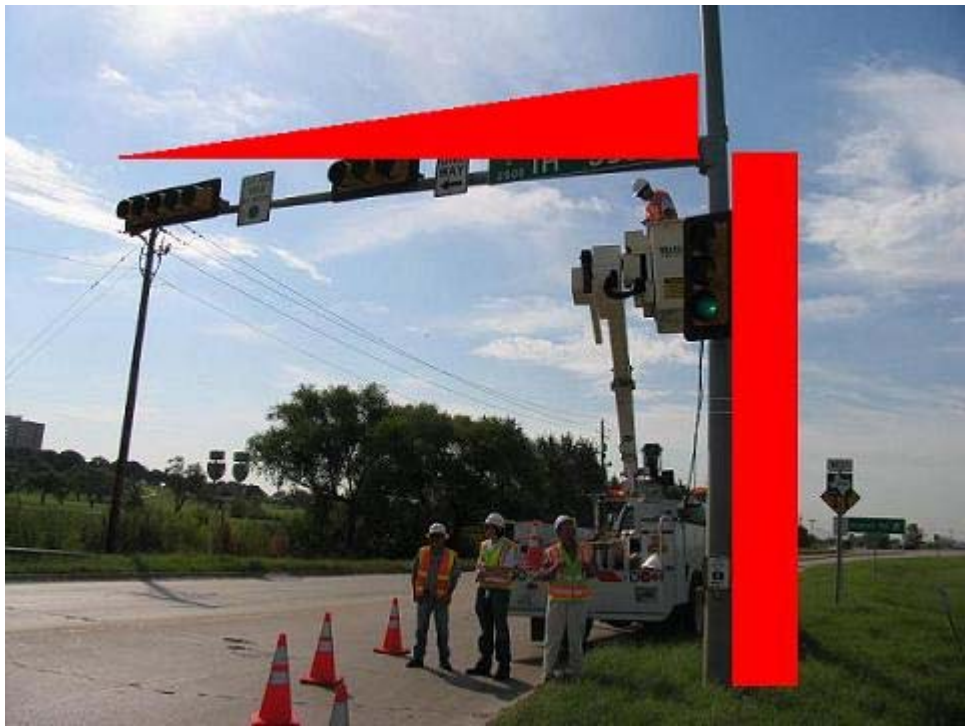
Using Koenigs' assumptions, the moment diagram for any cantilever traffic signal structure was greatly simplified to be represented as shown in Figure 2.1.1 [28]. In this figure, the mast-arm is simply a cantilevered beam. To transform this service loading into a testing apparatus, two mast-arms were tested back to back so that the structure could be modeled as a simply supported beam, as shown in Figure 2.1.2 [28]. In this test setup, the critical connection details and loading were both located in the center of the beam. The symmetry of the test setup allowed two specimens to be tested at once and did not require construction of a fixed support.

Figure 2.1.1 Moment Diagram Superimposed on Cantilever Mast Arm

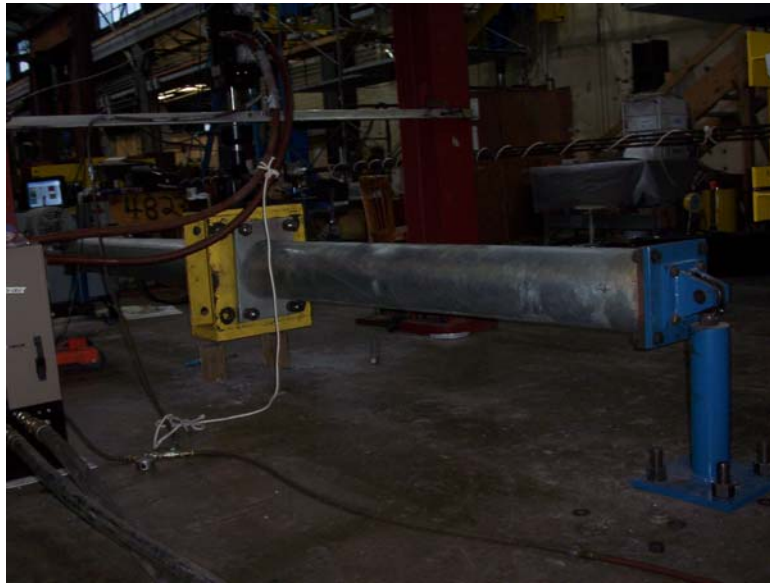
The specimens were tested in pairs with the base plates bolted to a load box, and the end plates bolted to end restraints. The base plate was bolted to the load box using all-thread rods approximately 1 foot in length. The end plate was bolted to end restraints with high-strength steel bolts. Figure 2.2.1 shows the test setup with mast arms in place. The end restraint in the right of the photo allowed for rotation only of the mast arm end. The end restraint in the far left of the photo allowed for both rotation and translation of the mast arm end. Rotational freedom was provided by a lubricated ball clevis at each end.

Figure 2.2.1 Test Setup with Mast Arms

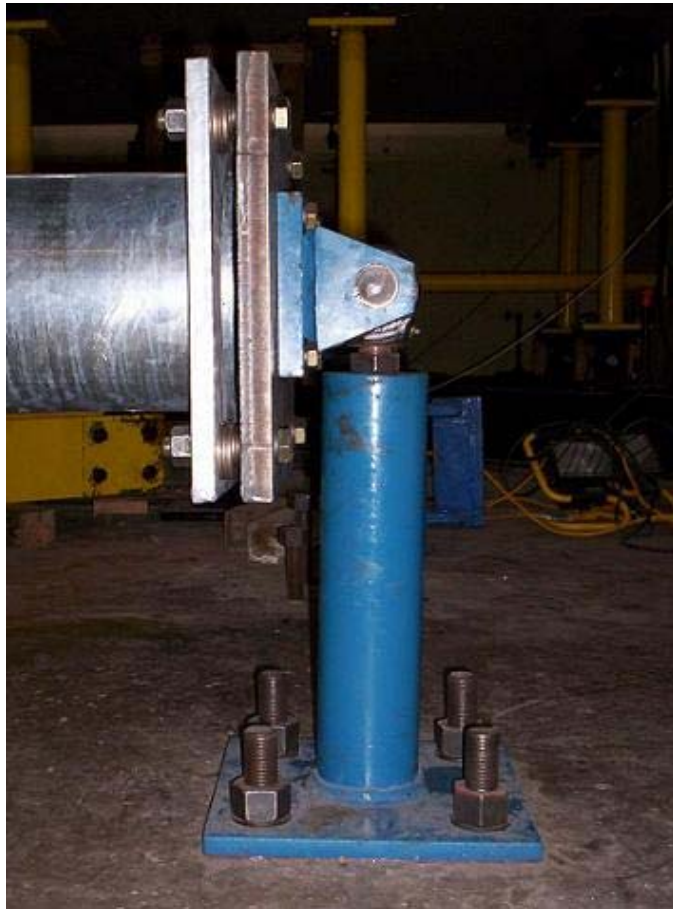
Each fixed end consisted of a riser section and one or two spherical rod eyes and clevises. The spherical rod eye allowed for corrections due to alignment imperfections. Figure 2.2.2 shows the end hardware that allowed for rotation only. This hardware consists of a single fixed riser section connected to a spherical rod eye and clevis. Figure 2.2.3 shows the end hardware that allowed for rotation and translation. This hardware consists of a single riser section between two spherical rod eyes and clevises.

Figure 2.2.2 End Restraint that Allows for Rotation Only

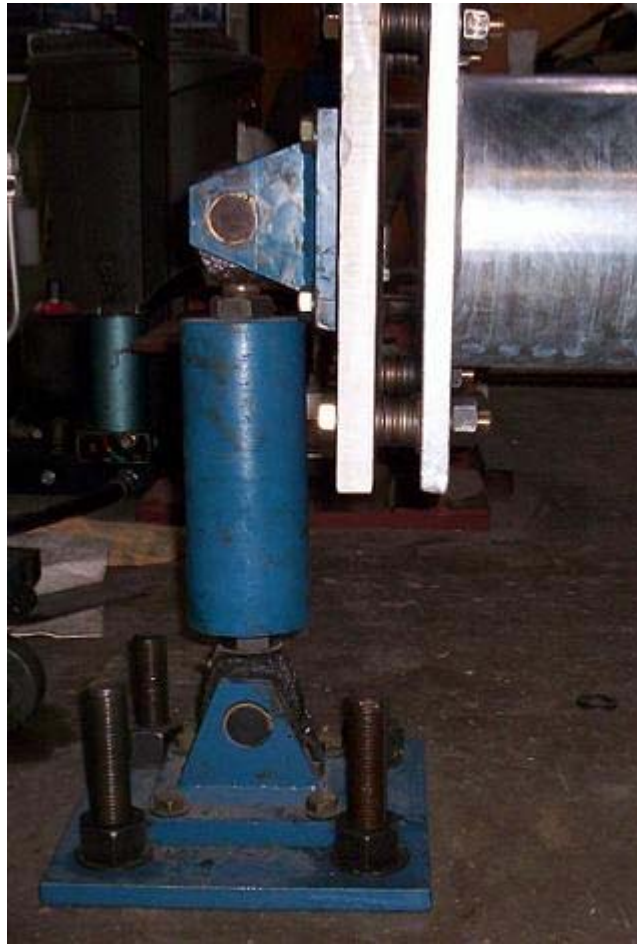
Figure 2.2.3 End Restraint that Allows for Rotation and Translation

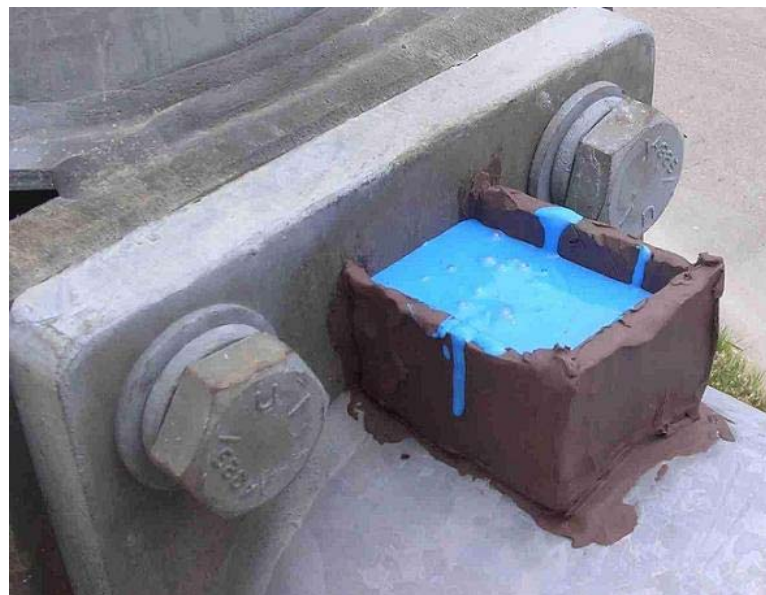
When the mold was mixed and the clay dam was in place, the mold mixture was poured into the dam. It took at least 16 hours for the material to set completely. Figure 2.3.2.1 shows a complete clay dam filled with the molding material for a mast arm weld.

Figure 2.3.2.1 Clay Dam Filled with Molding Material

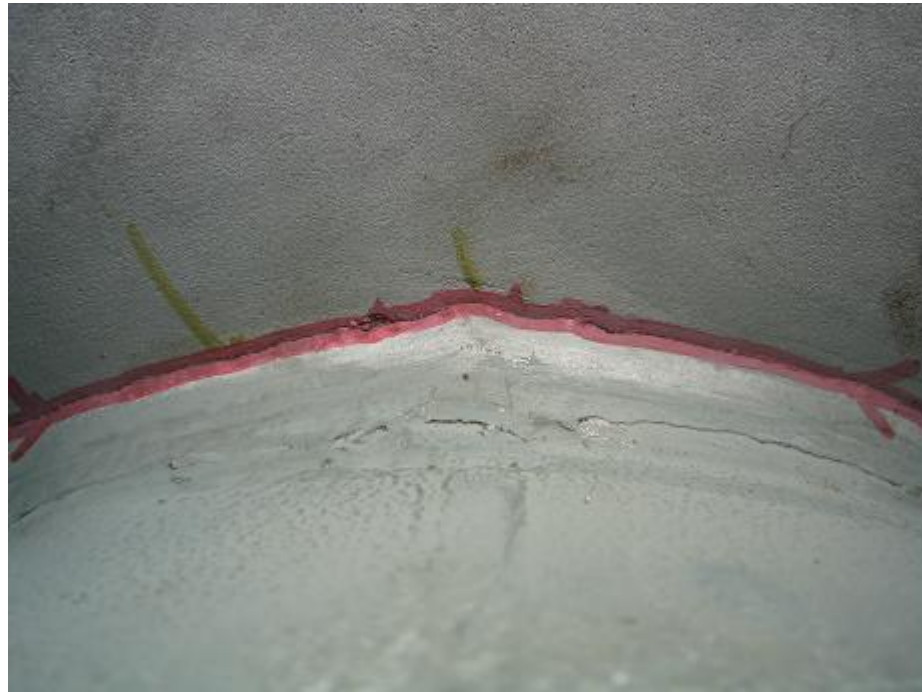
Previous test results show that welds in steel treated with UIT have had fatigue crack initiation in the UIT application line [5, 6, 12, 15, 28]. Fatigue crack initiation has mainly occurred at the mast arm weld toe, and the fatigue crack propagation has mainly been through the HAZ of the mast arm base metal [28, 29, 30]. Koenigs' and others' tests with UIT application to the base plate-mast arm weld at the University of Texas at Austin have only applied UIT to the mast arm weld toe of the base plate-mast arm weld in tests to date [28, 29, 30]. UIT has only been applied to the mast arm weld toe of the base plate-mast arm weld because previous tests have found this location to be the site of the majority of mast arm failures [28, 29, 30]. Tests at the University of Texas at Austin have had all but two mast arms fail along the UIT application of the mast arm weld toe [28, 29, 30]. Two mast arms had fatigue crack initiation along the untreated base plate weld toe [29]. In other words, two mast arms treated with UIT along the mast arm weld toe had fatigue cracks in the untreated base plate weld toe, as shown in Figure 3.1.1.

Figure 3.1.1 Fatigue Crack Along Un-Treated Base Plate Weld Toe [29]

The mast arms were cycled between a minimum stress of 16 ksi and a maximum stress of 28 ksi for a stress range of 12 ksi at the mast arm weld toe. The specifics of the test are included in Appendix A. The fatigue lives of the two mast arms are given in Table 3.2.1. TXuBLGP failed first at 246,045 cycles with fatigue cracking along the treated mast arm weld toe in the UIT application area. This failure was the same as all other failures in similar mast arms with UIT application fatigue tested at the University of Texas at Austin [28, 29, 30]. TXuBLGP underwent weld repair along the fatigue crack, and the test was restarted. TXuALGP failed at 263,044 cycles in the untreated base plate weld toe. Failure along the untreated base plate weld toe had not occurred in any other fatigue tests of similar specimens [28, 29, 30]. The TXuALGP fatigue crack is shown in Figure 3.1.1. TXuBLGP was reexamined by Freytag at this point, and a

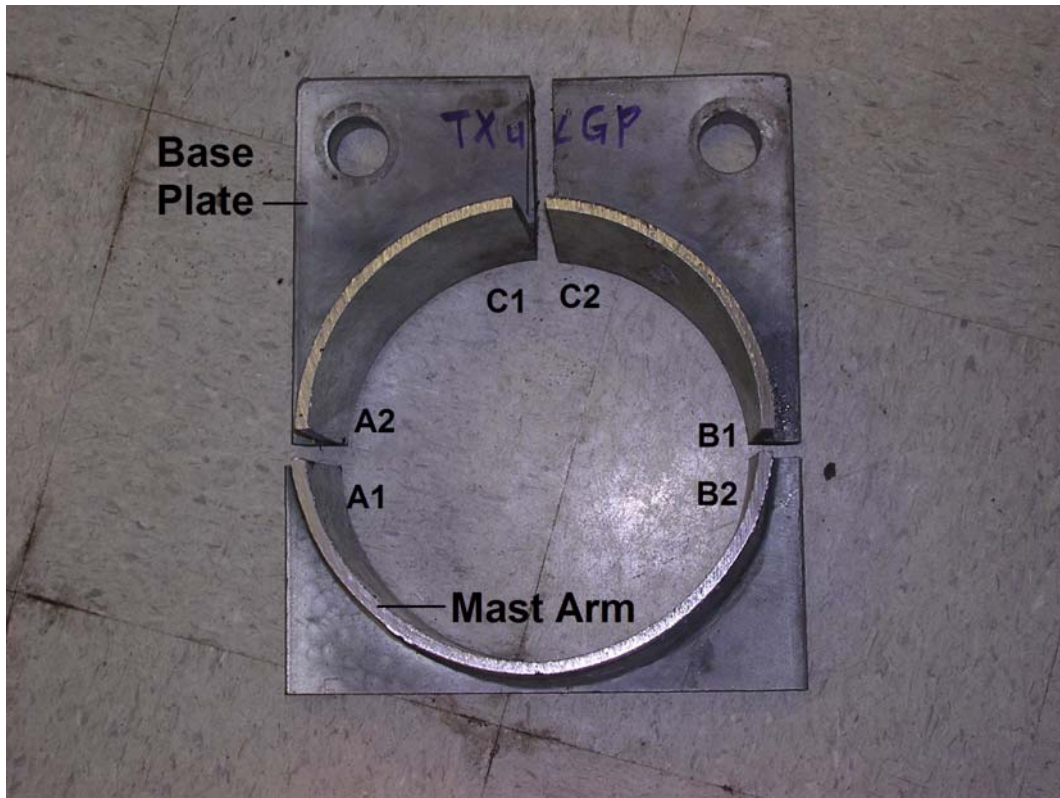
The author examined Freytag's mast arm fatigue cracks that initiated in the base plate weld toe. First, the mast arm of sample TXuALGP was shortened to a length of 6 inches from the base plate. Next, three cross-section samples were cut from TXuALGP. Two samples, labeled A and B were taken from the horizontal axis, and the third sample, labeled C, was taken from the top of the specimen along the vertical axis, as shown in Figure 3.3.1 and Figure 3.3.2.

Figure 3.3.1 Top View of TXuALGP, Indicating Location of Test Samples

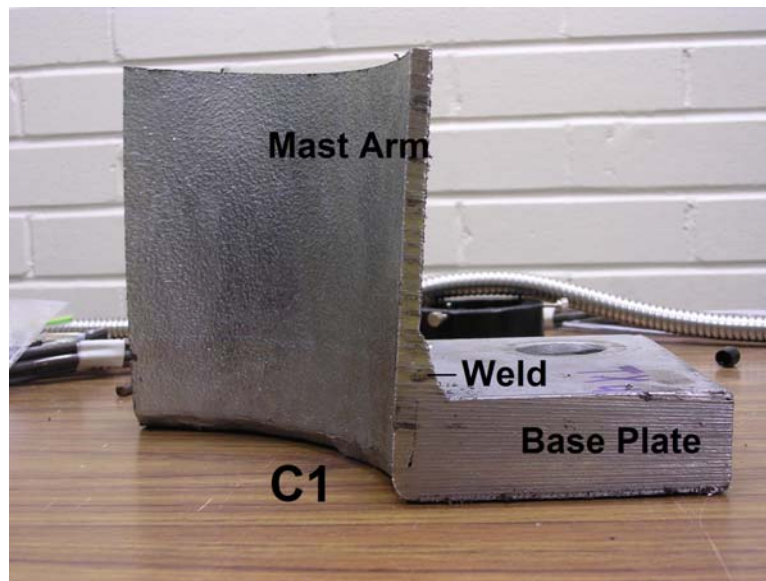
Figure 3.3.2 Cross-section Side View of C Sample Location

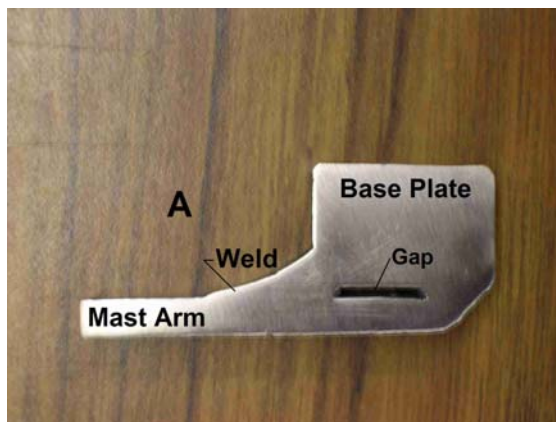
weld toe, they do show that there is an incomplete connection between the mast arm and the base plate, or a “gap”, as shown in Figure 3.4.1.

Figure 3.4.1 Right Profile of TXuALGP Horizontal Cross-section A (A2)

Figure 3.4.1 shows that the hole cut in the base plate to accommodate the mast arm was cut too large, resulting in an incomplete connection of the mast arm to the base plate. This may have weakened the mast arm-base plate connection and may have lead to the fatigue crack initiation at the base plate weld toe. However, fatigue crack initiation at the base plate weld more likely occurred due to poor welding, as indicated by the slag especially visible in Figure 3.4.5.

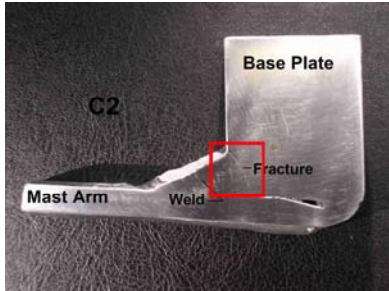
Closer inspection of the TXuALGP vertical cross-section, C, shows that the unusual fatigue crack originated from the base plate weld toe, as shown in Figure 3.4.3, and not the root of TXuALGP as originally hypothesized. Figure 3.4.5 shows the 90x magnification of TXuALGP vertical cross-section left profile C1 at the base plate weld toe where there is slag visible at the base plate weld toe, which may have contributed to the fatigue crack initiation. As is visible in Figure 3.4.3, at no time does the fatigue crack intersect the gap that exists between the mast arm and the base plate.

Figure 3.4.2 Section C2

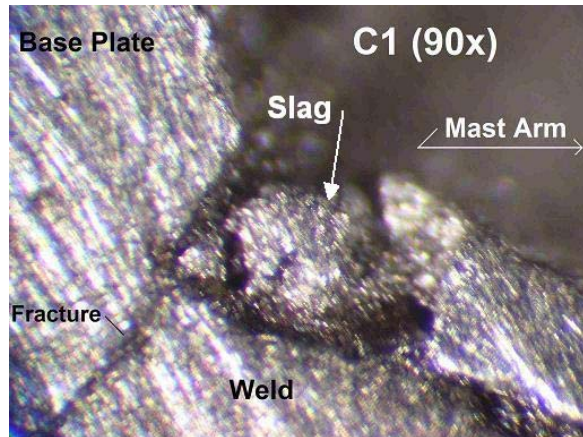
Figure 3.4.5 90x Magnification of C1

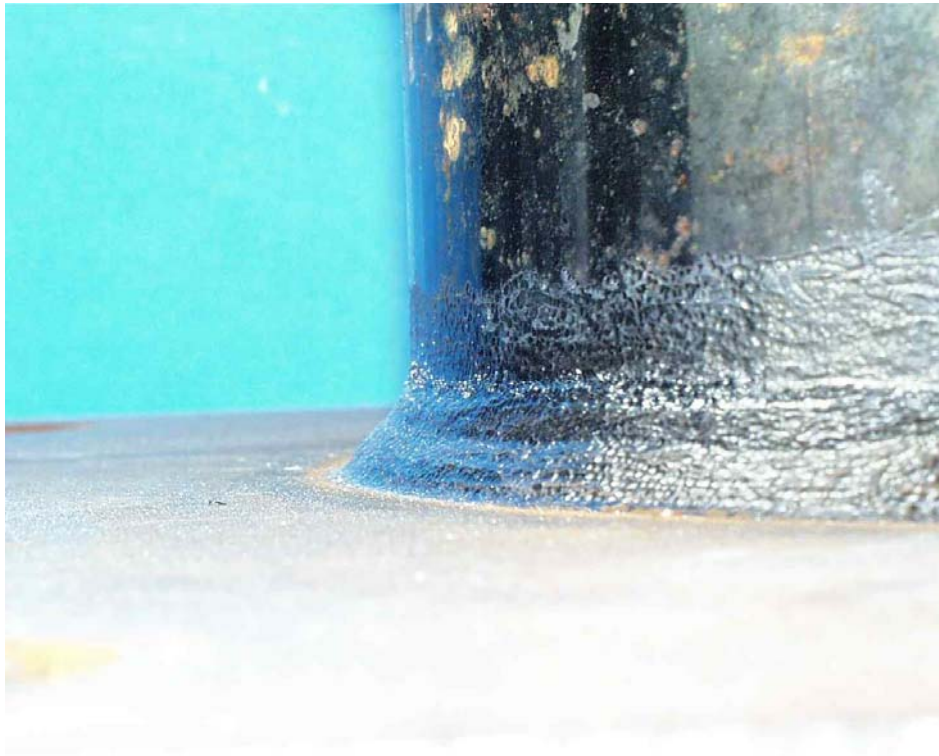
Koenigs tested the effects of UIT both when UIT is applied before hot-dip galvanization, and when UIT is applied after hot-dip galvanization. Representatives from Applied Ultrasonics warned that the heat incurred during the hot-dip galvanization process, when performed after UIT application, would undo the benefits of UIT. An attempt was made to compensate for the heat influence of hot-dip galvanization on mast arm welds after UIT application. After a trained technician performed the standard UIT application under loaded conditions using the 3mm diameter pins in the multi-pin tool along the toe of the socket weld, the same settings were used for an additional treatment to an area around the socket weld. The resulting condition of the socket weld after the heat affected area treatment is shown in Figure 4.2.1.

Figure 4.2.1 UIT Application to Both Weld Toes and the HAZ on TXuCLGP

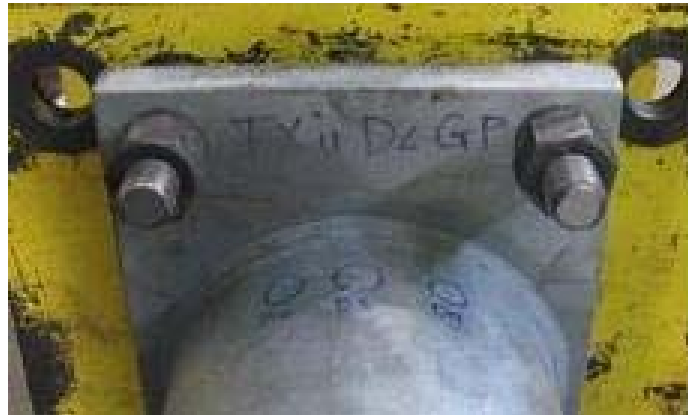
Next, the mast arm was loaded to the maximum load of 11.31. The temperature was measured with a non-contact thermometer prior to heating at five locations on each mast arm. All five temperature reading locations were 1.5 inches from the mast arm weld toe. Two temperature reading locations were at either end of the UIT application line along the weld toe. Three temperature reading locations were at the middle most area of UIT application. The locations of the temperature reading locations are shown in Figure 4.3.3.1. The average temperatures at each location are shown in Table 4.3.3.2.

Figure 4.3.3.1 Location of the Middle-Most Temperature Reading Locations (Blue Circles Labeled D2, D3, and D4; The Endmost Temperature Reading Locations are Not Visible in this Picture)

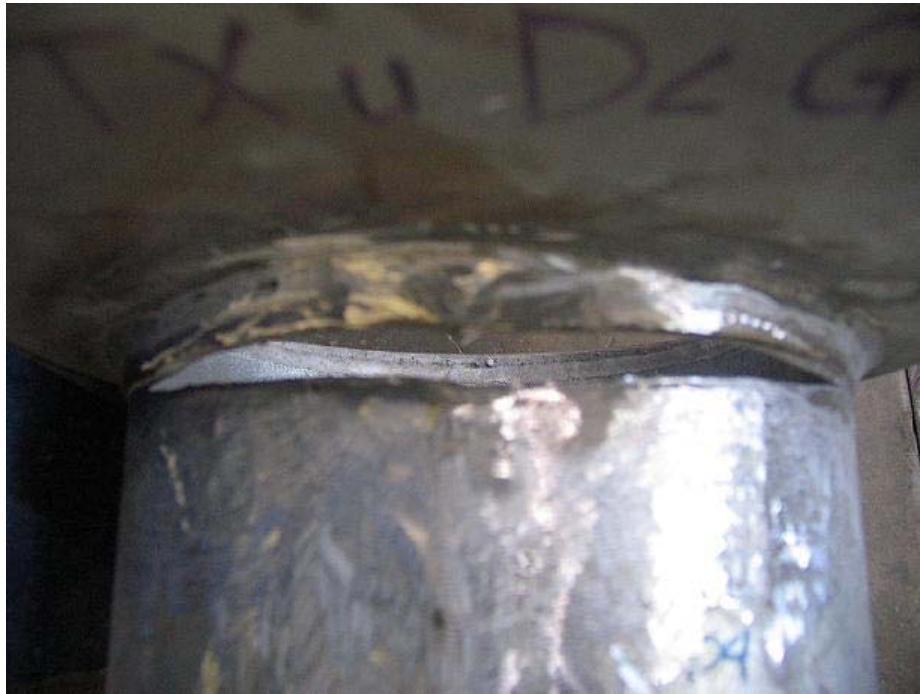
The controller first reported failure after 85,214 cycles. Mast arms TXuCLGP and TXuDLGP were visually inspected for cracks, and none were detected. At this point the controller had unknowingly been re-set, probably due to a brownout. When the test was restarted, the re-set controller misread data and induced a deflection of 2.5 inches in tension, which caused a massive fracture along the mast arm weld toe of TXuDLGP. A picture of this failure after grinding to remove the galvanization is shown in Figure 4.4.1 and Figure 4.4.2. Figure 4.4.2 shows the extreme angle created in the base plate of TXuDLGP during failure.

Figure 4.4.1 Top View of Crack Along the Mast Arm Weld Toe of TXuDLGP

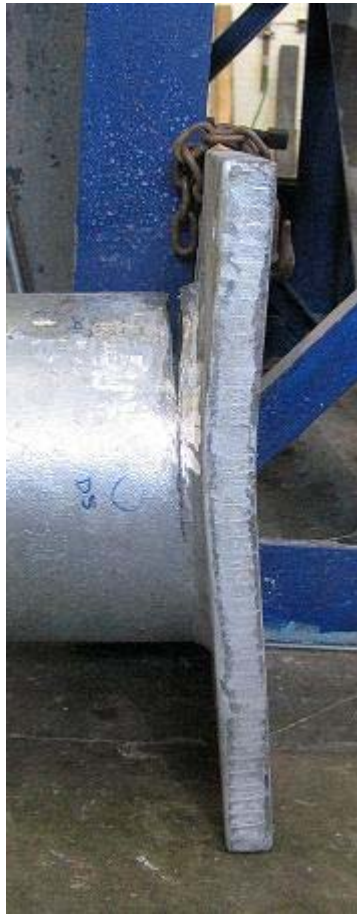
Figure 4.4.2 Side View of Mast Arm TXuDLGP After Cracking

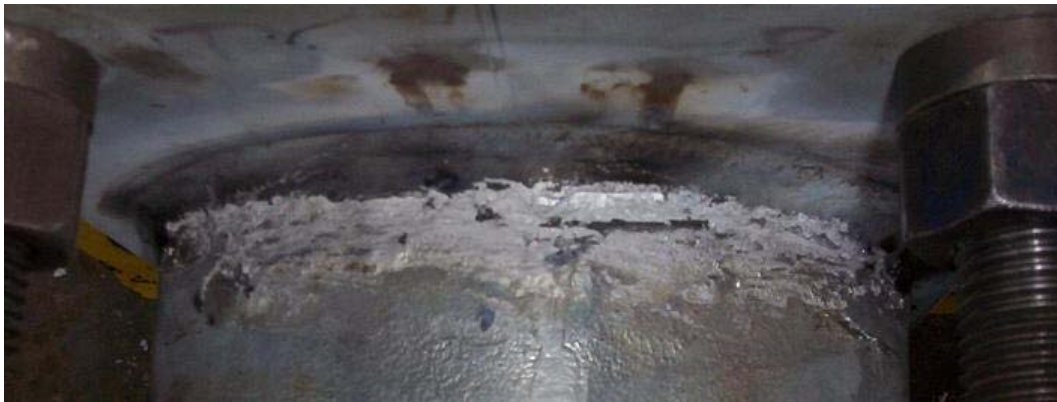
The controller first reported failure for mast arm TXuCLGP at 101,865 cycles. A picture of mast arm TXuCLGP at this point is shown in Figure 4.4.3. Visual inspection revealed no fatigue cracks. However, the thick galvanization repair along the weld toe prevented good inspection. Since no fatigue cracks were visible in TXuCLGP, the controller was reset, and dynamic testing continued.

*Figure 4.4.3 Mast Arm TXuCLGP After 1st Controller-Reported Failure
(101,865 cycles)*

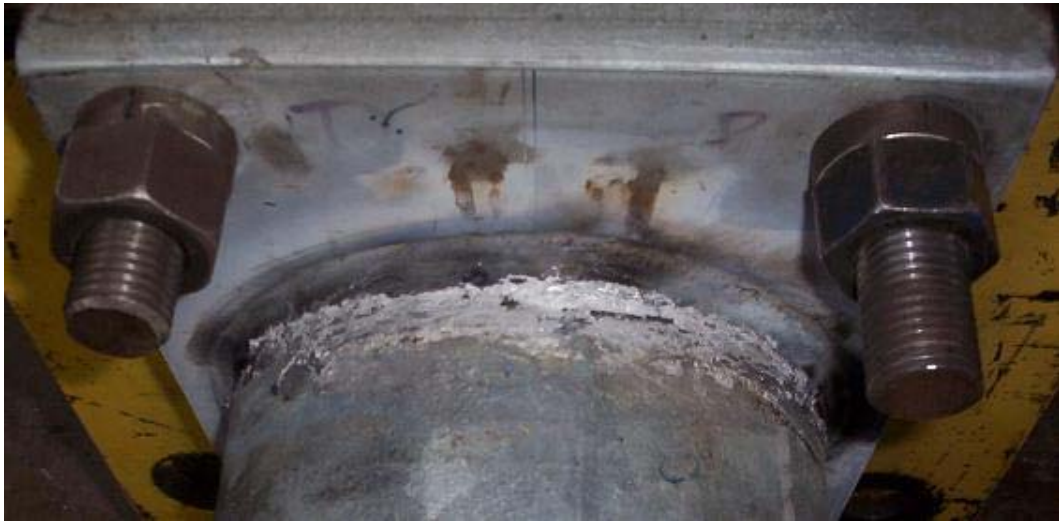
The controller reported failure again for mast arm TXuCLGP only 7,546 cycles later at 109,411 cycles. A picture of mast arm TXuCLGP at this point is shown in Figure 4.4.4. Visual inspection revealed cracking in the thick galvanization repair. Galvanization was removed with a screwdriver in the area of the cracked galvanization. However, the local galvanization removal did not reveal any cracks in the mast arm weld toe or surrounding metal. Since no fatigue cracks were visible in TXuCLGP, the controller was reset, and dynamic testing continued.

*Figure 4.4.4 Mast Arm TXuCLGP After 2nd Controller-Reported Failure
(109,411 cycles)*

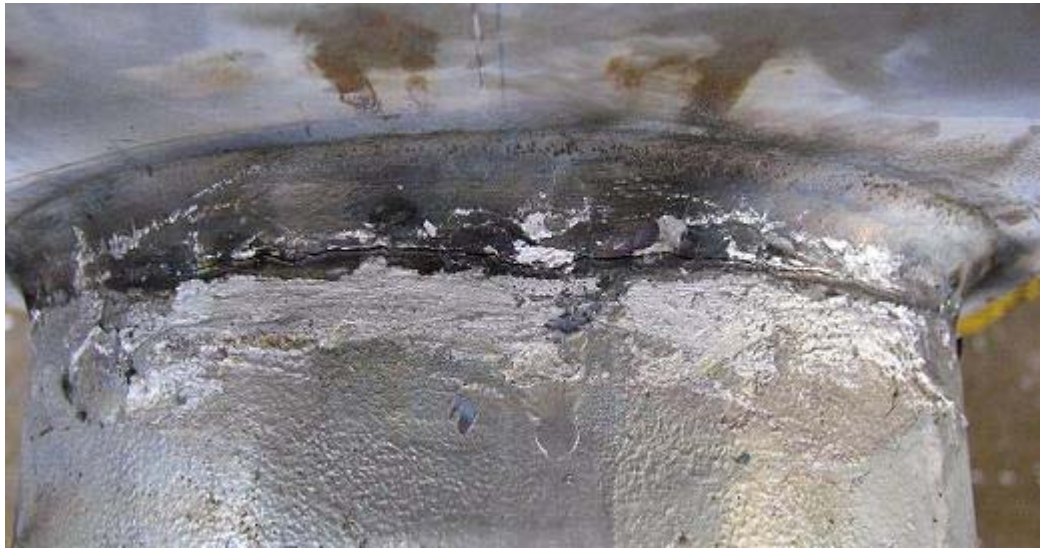
The controller reported a third and final failure for mast arm TXuCLGP 8,050 cycles later at 117,461 cycles. Visual inspection showed extensive cracking in the thick galvanization repair. Galvanization removal with a screwdriver of the cracked galvanization repair revealed visible cracking along TXuCLGP's mast arm weld toe. Removal of the entire thick galvanization repair with a screwdriver revealed the extent of fatigue cracking along TXuCLGP's mast arm weld toe, as shown in Figure 4.4.5. Figure 4.4.6 shows the fatigue crack on TXuCLGP's mast arm weld toe along the UIT application after highlighting.

Figure 4.4.5 Mast Arm TXuCLGP After 3rd Controller-Reported Failure (117,461 cycles) and After Removal of All the Thick Galvanization Repair

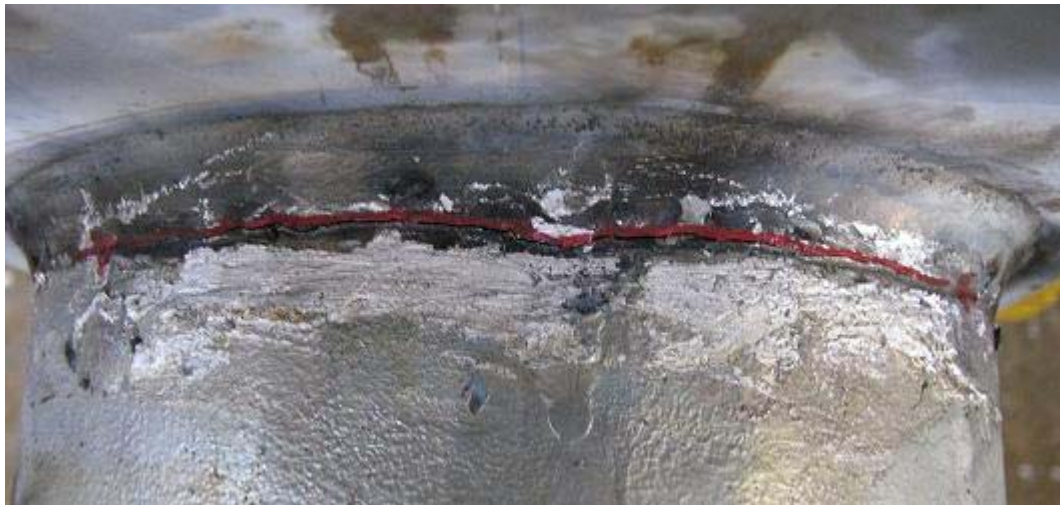
Figure 4.4.6 Highlighted Fatigue Crack on Mast Arm TXuCLGP Weld Toe Along the UIT Application

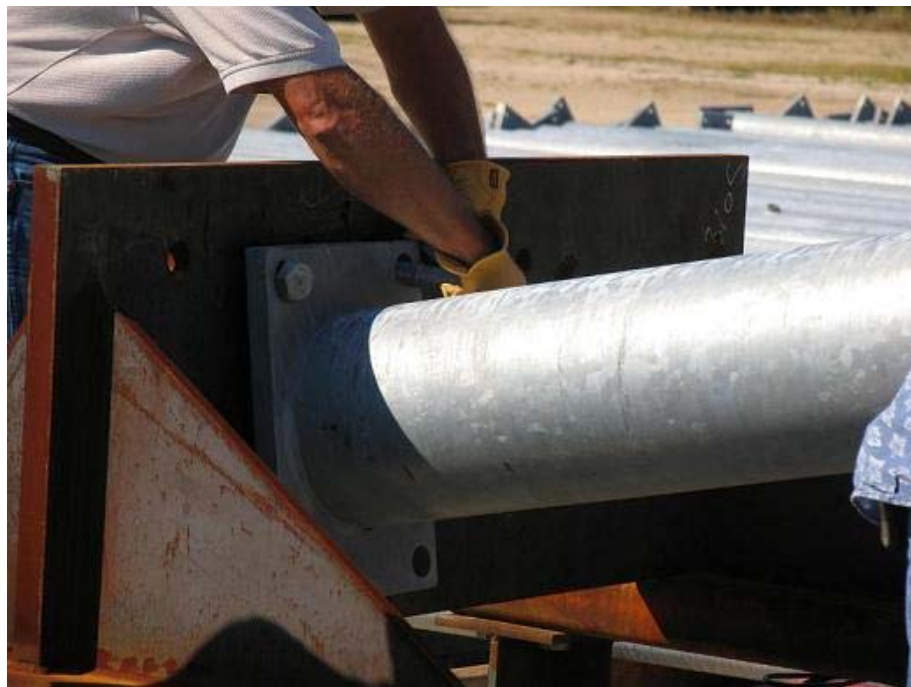
TransAmerican had a fixed testing stand made of steel that was connected to a concrete slab. The fixed testing stand had holes in it to allow for the different size base plates that TransAmerican fabricated and tested on site. It took a total of 3 people to connect the mast arm to the test stand. Figure 5.3.1.2 shows the mast arm being bolted into place.

Figure 5.3.1.2 Mast Arm Being Connected to Fixed Testing Stand

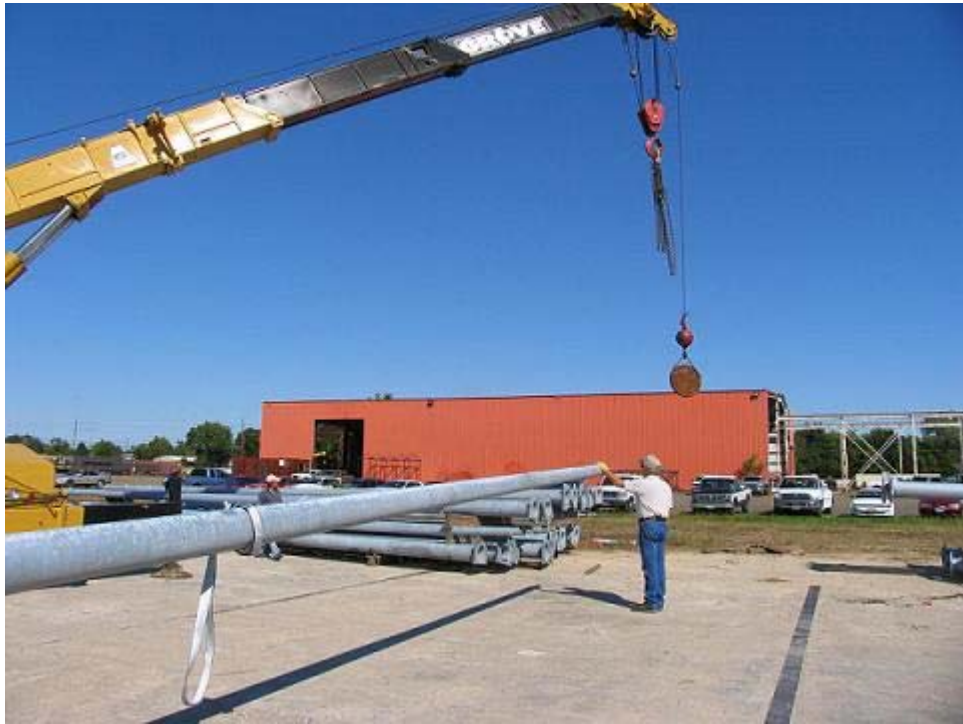
After the mast arm was bolted to the fixed testing stand it was loaded by crane with a 500-pound circular weight, as shown in Figure 5.3.1.3 and Figure 5.3.1.4. Figure 5.3.1.3 shows the crane as it moved a 500-pound circular weight to the end of the mast arm to induce dead load. Figure 5.3.1.4 shows personnel securing the 500-pound weight in place. Figure 5.3.1.5 shows a close-up of the 6 inch extension at the end of the mast arm that was used to support the 500-pound circular weight during UIT application.

Figure 5.3.1.3 Crane Moving the 500-Pound Circular Weight to the Mast Arm
End

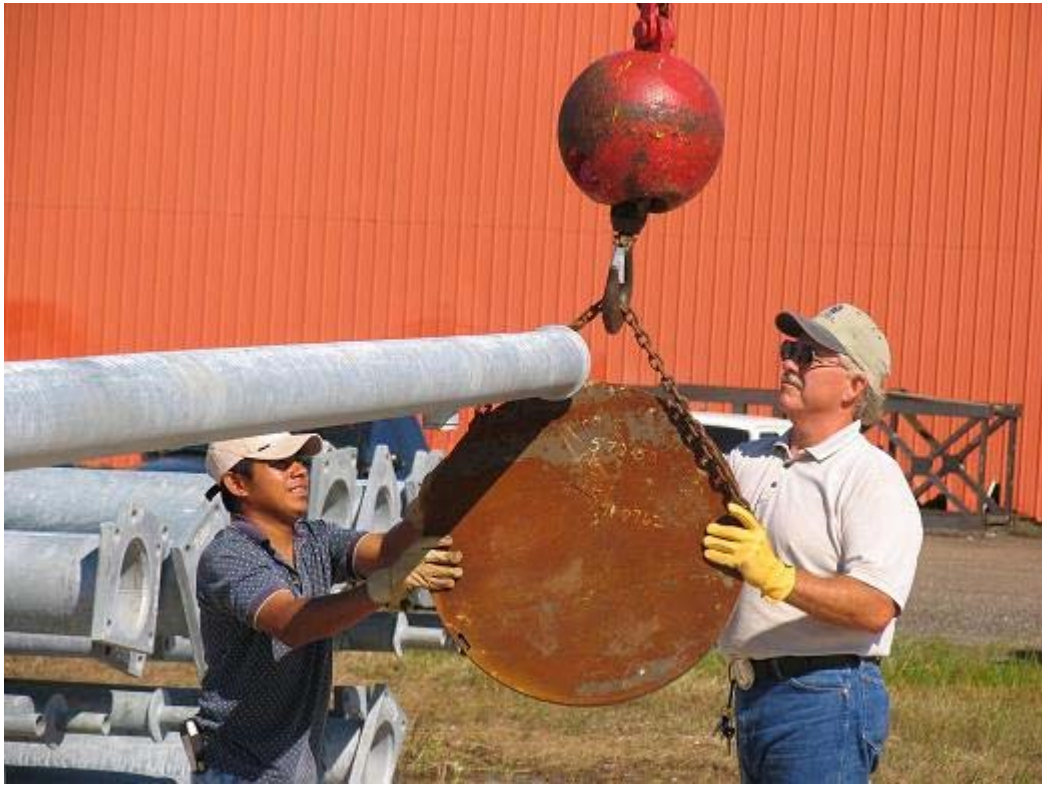
Figure 5.3.1.4 Placing the 500-Pound Circular Weight on the End of the Mast Arm

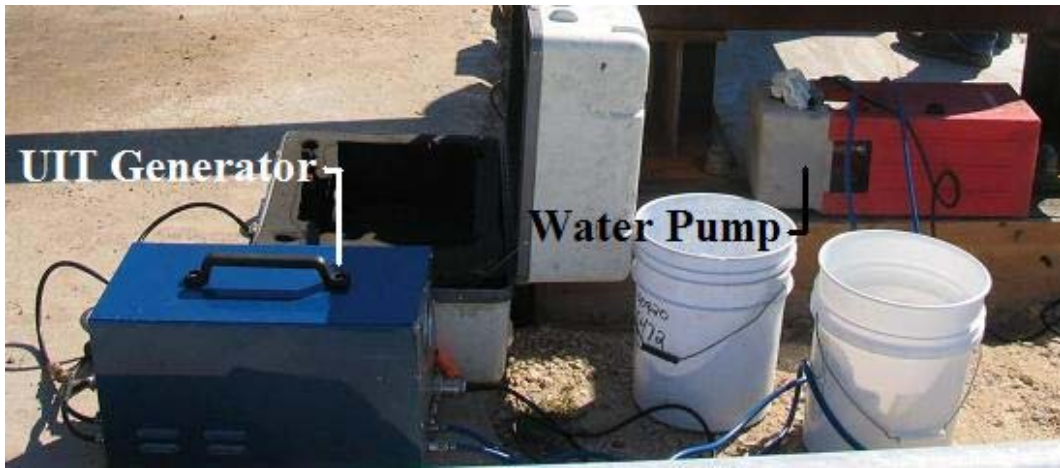
First, the power generator was turned on. The power generator supplied power to the UIT generator. Next, the water pump was turned on to cool the UIT generator. As explained in Appendix B, the UIT generator produces the ultrasonic oscillations that are utilized by the UIT tool to treat the steel weld. Then the UIT generator was turned on to maximum power, which corresponded to 80 volts. The UIT tool used 10 amps, so the power applied during UIT application was 800 watts. The UIT generator was set at maximum power for all mast arm applications. Figure 5.3.2.1 shows the UIT generator and the water pump. Figure 5.3.2.2 shows the UIT generator, the UIT tool, and the power generator.

Figure 5.3.2.1 UIT Generator (Blue Box on Left) and Water Pump (Red Box on Right)

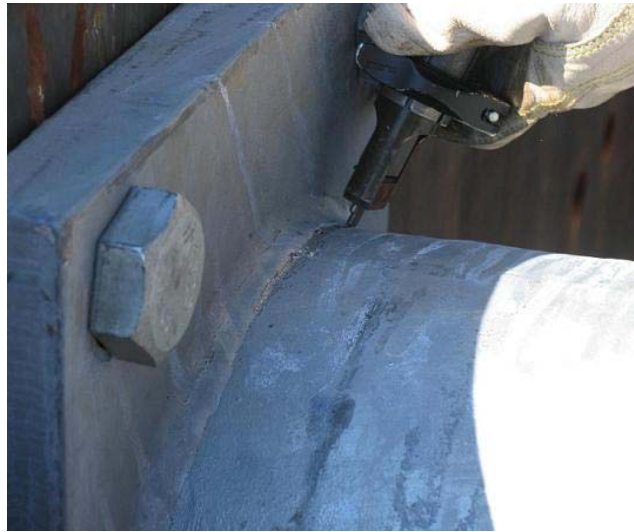
The UIT tool used during application was a 3 mm diameter multi-pin head on the tool, with two 3 mm pins installed. Applied Ultrasonics has found that two pins perform better than three or four 3 mm diameter pins during application to 10-inch diameter mast arm weld toes. The reason that two pins give superior UIT application is that the small diameter of the mast arm prevents three or more pins from coming into contact during application. A flat plate, for example, would probably get superior UIT application from three or four 3 mm diameter pins in the multi-pin tool because all of the pins would be able to contact the steel during treatment. Figure 5.3.2.3 shows UIT application.

Figure 5.3.2.3 Application of UIT to a Mast Arm Weld Toe

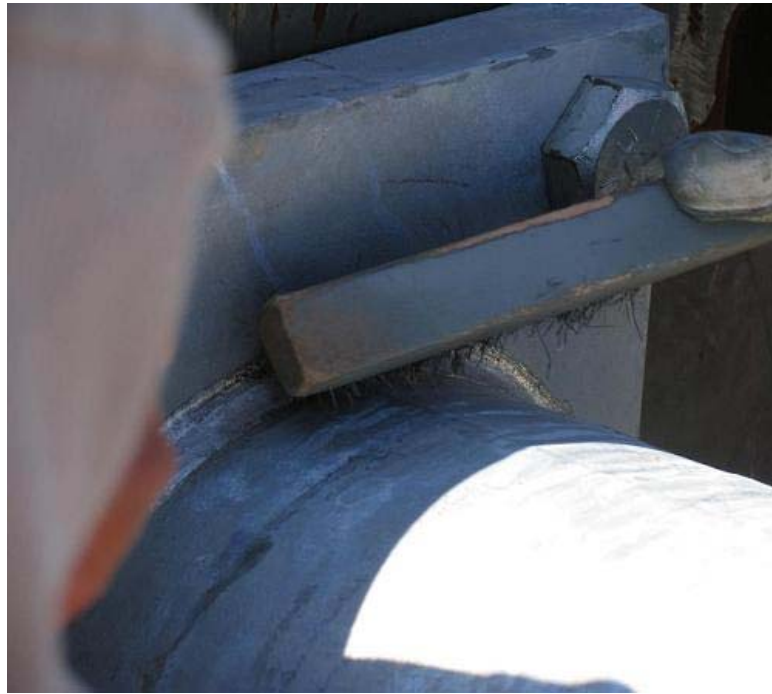
After the example UIT application by the trained technician, a TxDOT inspector inspected the groove produced by UIT application. One hindrance to perfect UIT application is when existing galvanization on the mast arm weld toe does not flake off from UIT application, or flakes off and then gets between the UIT tool pins and the mast arm weld metal. Pieces of galvanization can result in a barrier between the UIT tool and the metal to be treated. According to the Applied Ultrasonics technician, during past UIT applications, pieces of galvanization have prevented proper impact of the weld metal by the UIT tool. If either the galvanization does not flake off during treatment, or galvanization that has flaked off gets between the UIT tool and the area of treatment, gaps in proper UIT application will occur. The UIT application area must be cleared of any remaining galvanization after UIT application for inspection for incomplete treatment. The trained technician suggested using a screwdriver to remove galvanization after UIT application, if a screwdriver is available. Oil cannot be used to remove galvanization after UIT application, because oil will interfere with application of the zinc-rich paint to repair the area after UIT application. TxDOT inspectors recommend using a wire brush for galvanization removal after UIT application. Figure 5.3.3.1 shows galvanization being removed with a wire brush.

Figure 5.3.3.1 Removal of Galvanization with a Wire Brush

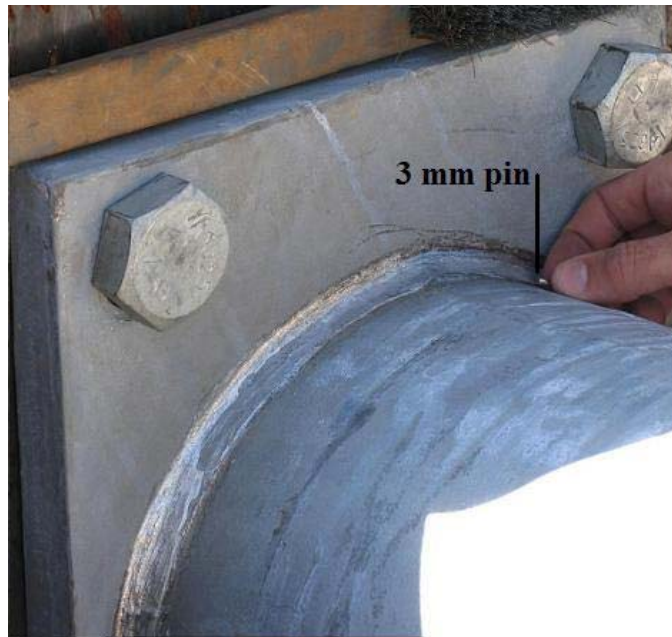
Figure 5.3.3.3 Measurement of UIT Application Groove by Rolling a 3 mm Diameter Pin from the UIT Tool in the UIT Application Groove

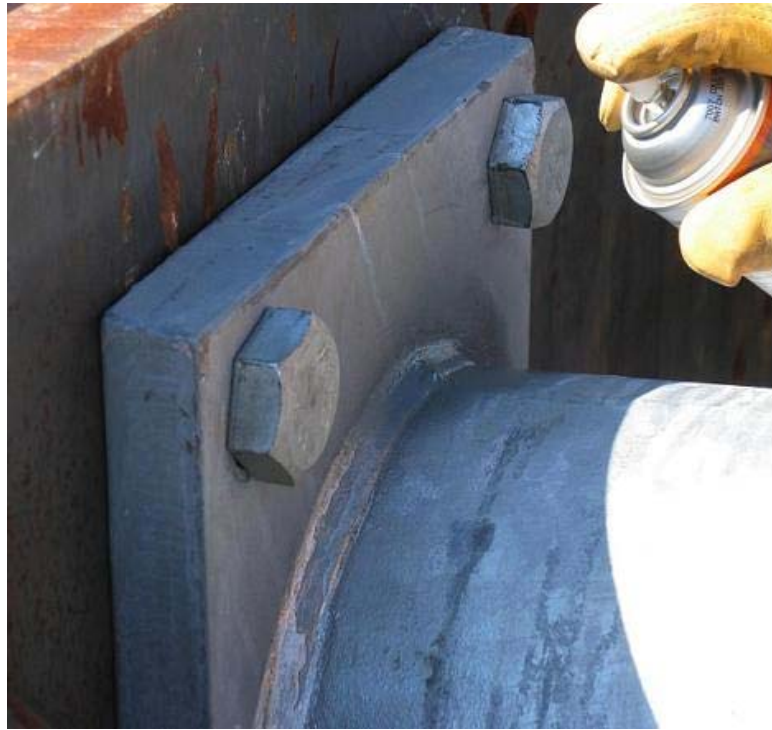
After satisfactory inspection of the UIT application by a TxDOT inspector, a zinc-rich paint repair was applied in two coats by the TxDOT inspector. The first coat was allowed to dry before the second coat was applied. The zinc-rich paint used at the TransAmerican fabrication yard by TxDOT inspectors was Rust-oleum Cold Galvanizing compound, which contained 93% pure zinc. Figure 5.3.4.1 shows the paint being applied. Figure 5.3.4.2 shows the area of UIT application while the paint is drying. Figure 5.3.4.3 shows a completed UIT application after repair is completely dried.

Figure 5.3.4.1 Application of Zinc-Rich Paint
