**Ultrasonic Impact Treatment of Traffic
Signal Mast Arm Welds**

Thesis

Master of Science in Engineering

The University of Texas at Austin

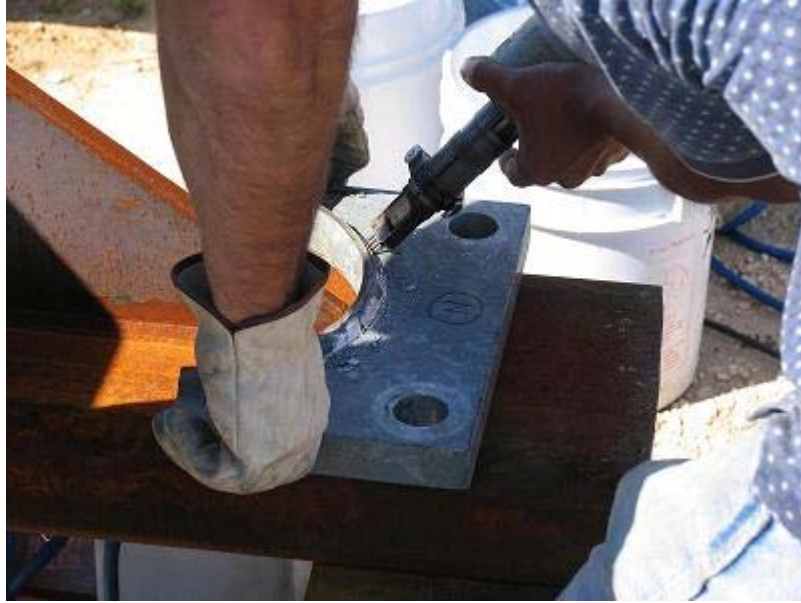
Figure 5.4.1 Employee Applying UIT to a Test Plate Weld

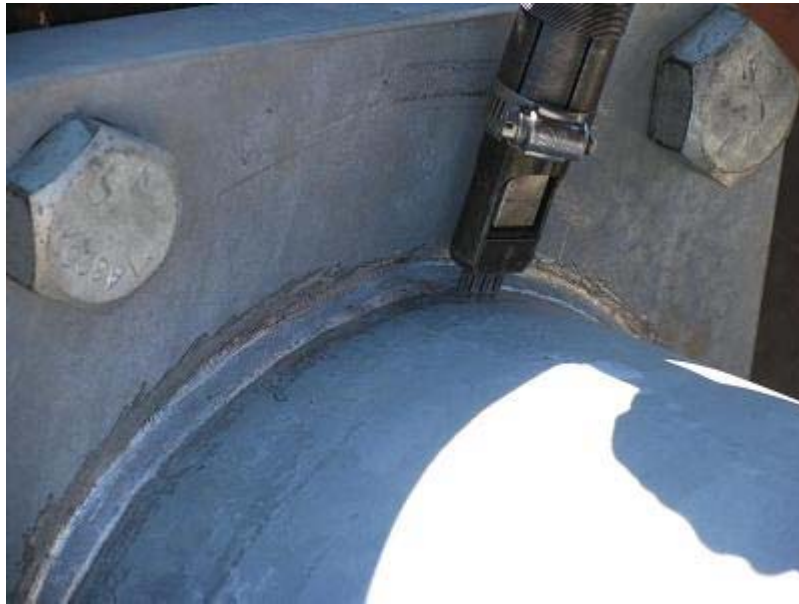
Figure 5.4.2 Employee’s First UIT Application to a Mast Arm Weld

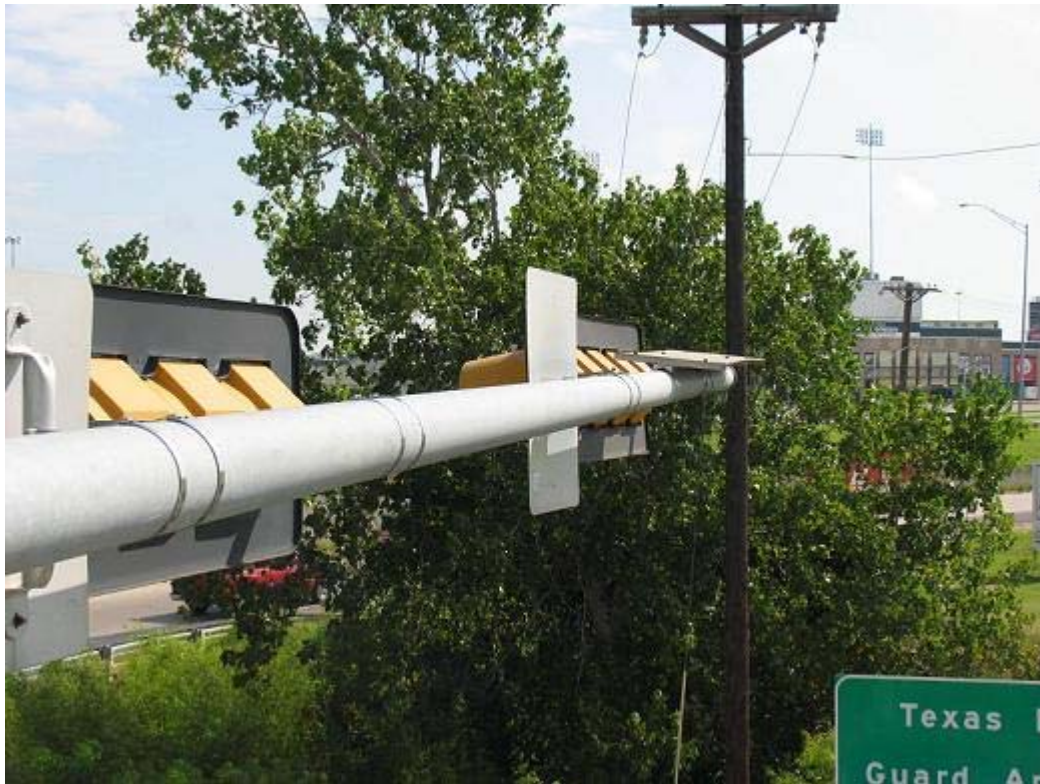
Figure 6.2.4 Horizontal Damping Plate on Mast Arm 2

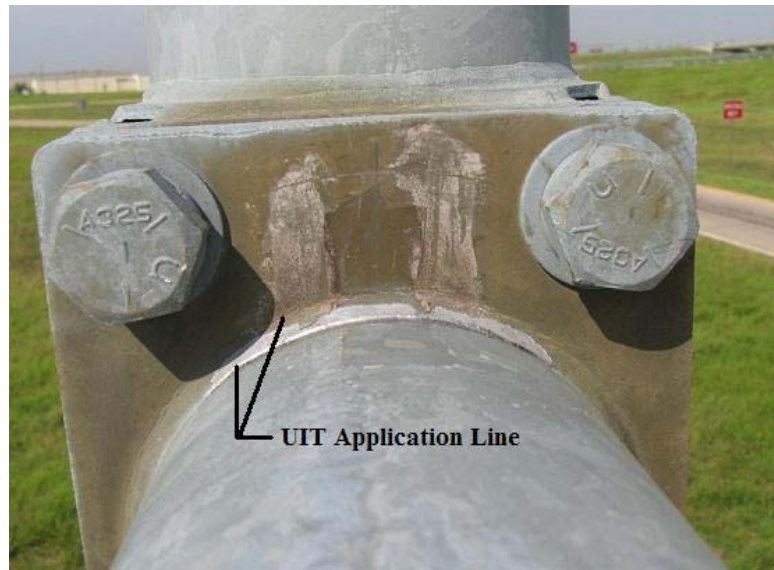
Figure 6.2.2.1 Mast Arm 1 After UIT Application.

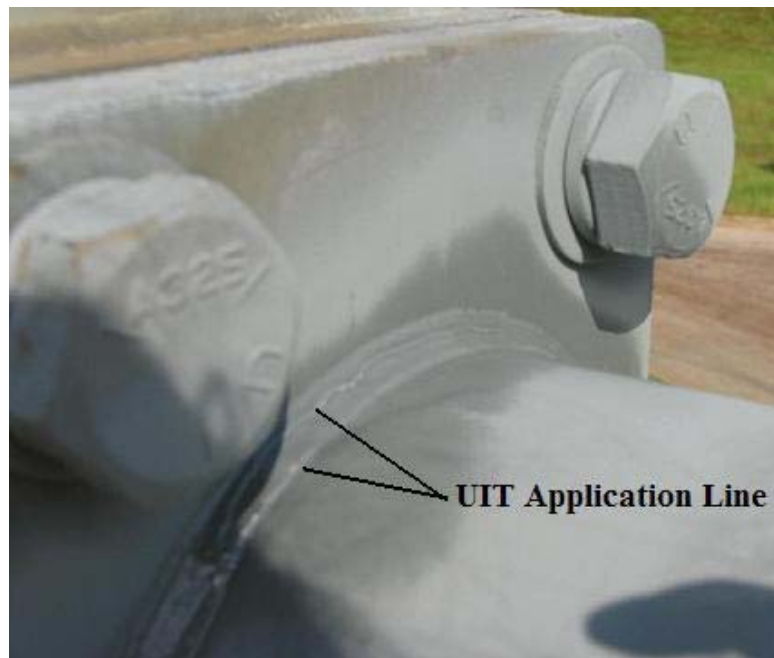
Figure 6.2.2.2 Mast Arm 1 After UIT Application and Spray-on Galvanization Repair

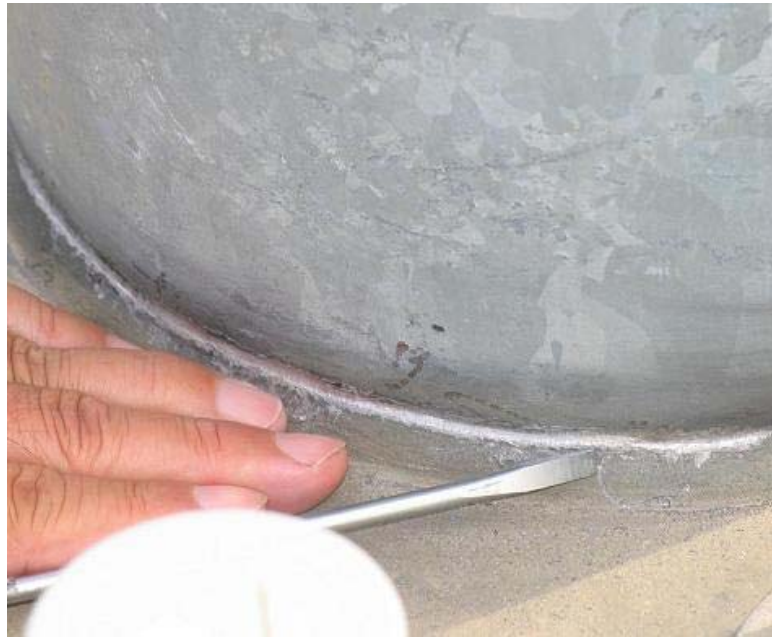
Figure 6.2.2.3 UIT Application at the bottom of Mast 2

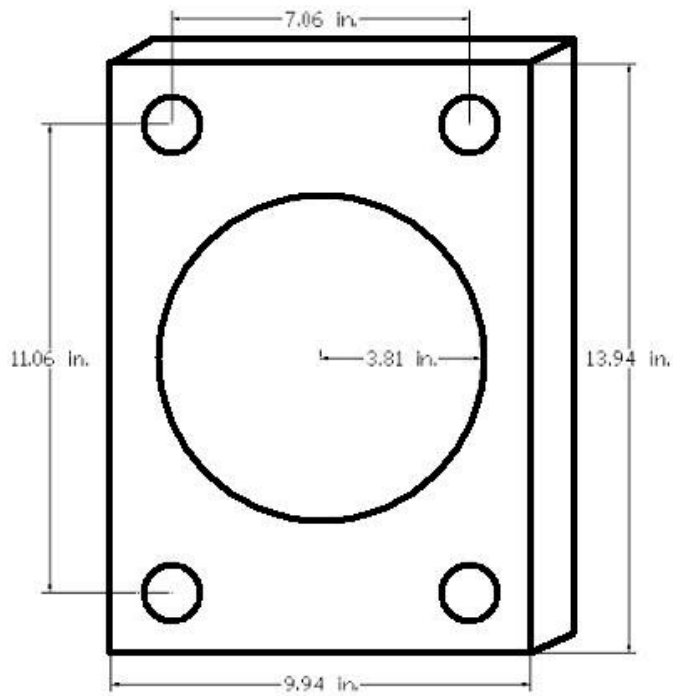
Figure 7.2.2 DN Mast Arm Baseplate Dimensions

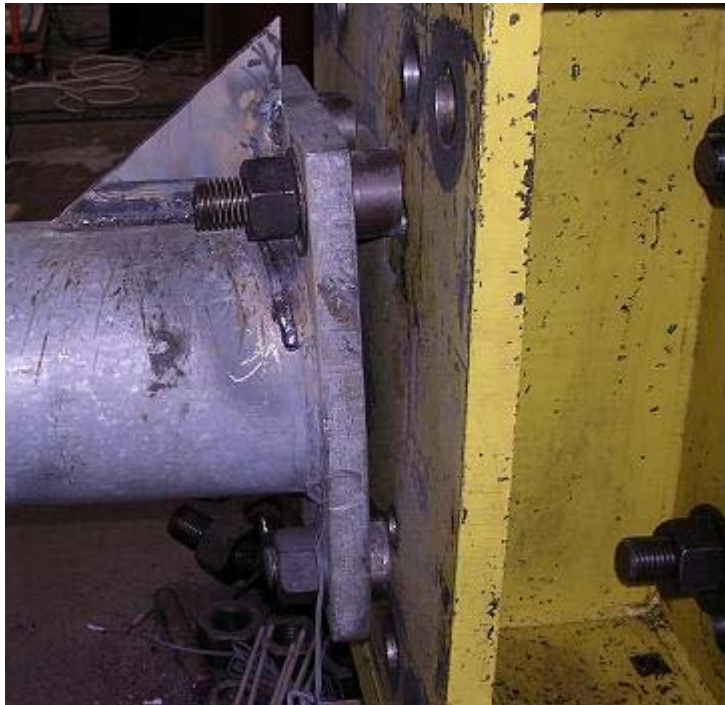
*Figure 7.3.1 Beveled Washers Connecting the Mast Arm Baseplate to the Load
Box*

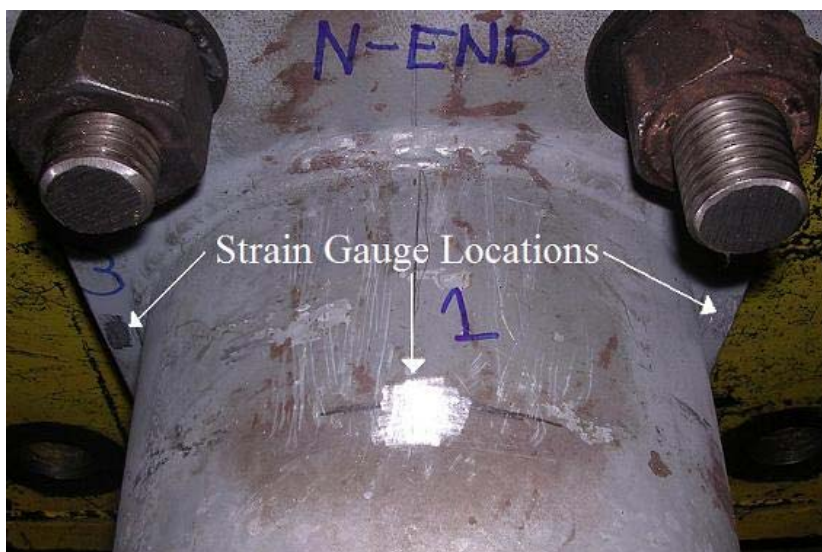
Figure 8.2.1 Locations of Strain Gauges

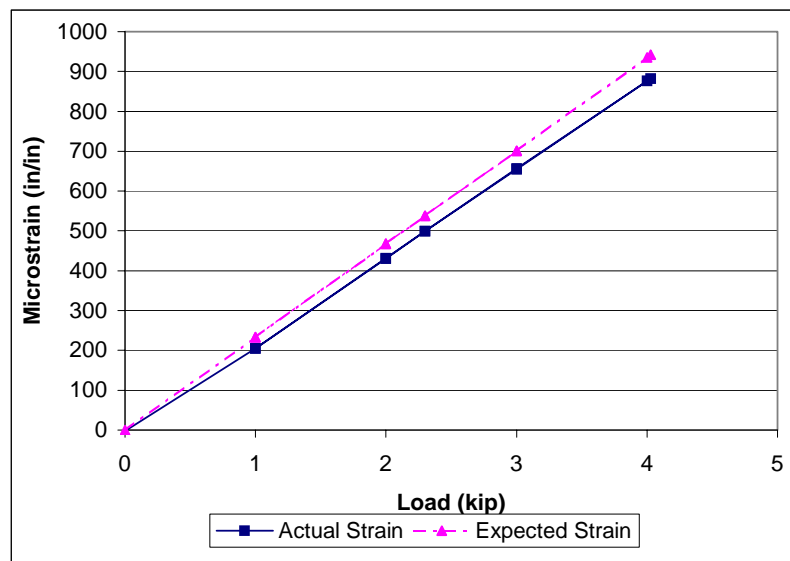
Figure 8.2.2 Actual and Expected Strain at 3 Inches from the Mast Arm Weld Toe of Specimen DU

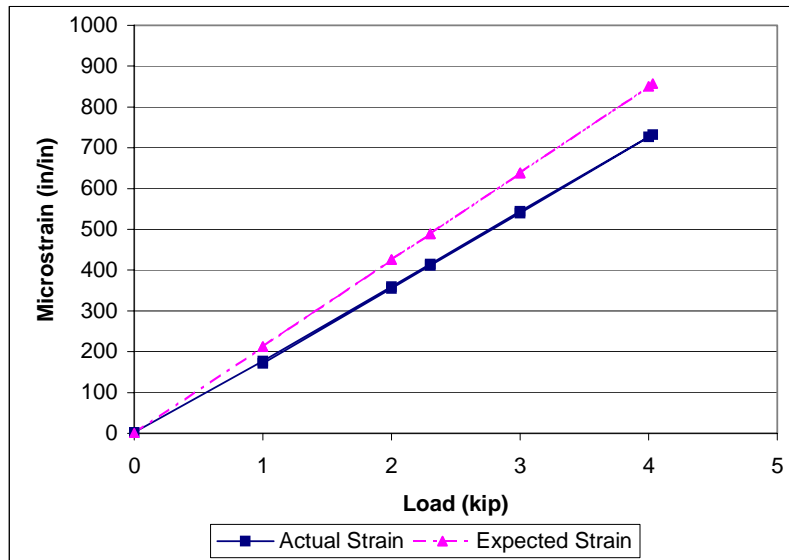
Figure 8.2.3 Actual and Expected Strain at 3 Inches from the Mast Arm Weld Toe of Specimen DN

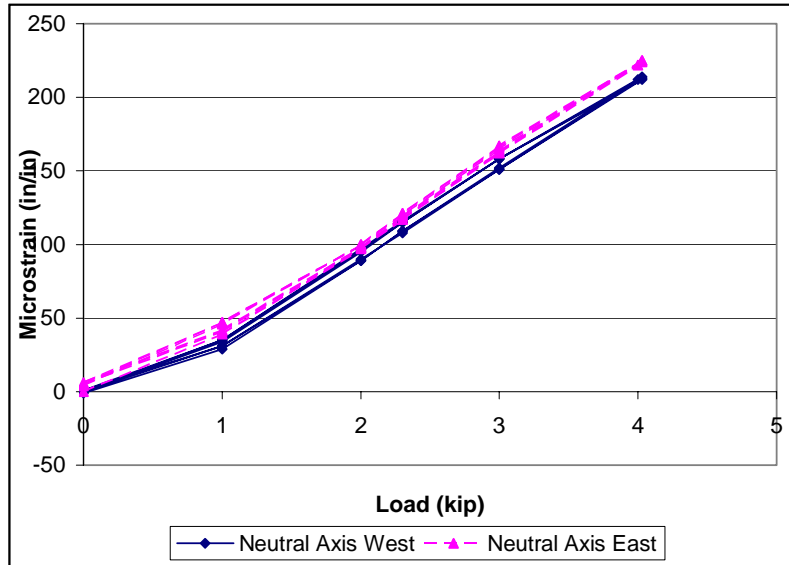
Figure 8.2.4 Strain at the Mid-Height of Baseplate DU

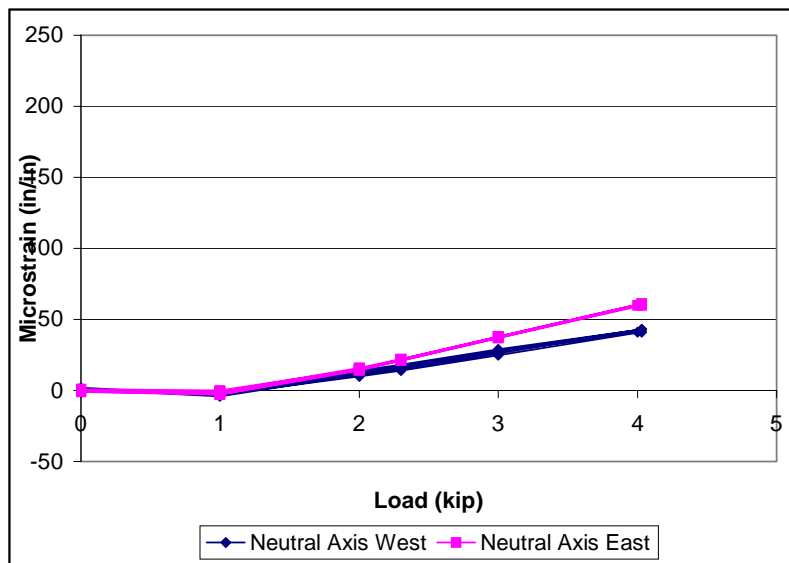
Figure 8.2.5 Strain at the Mid-Height of Baseplate DN

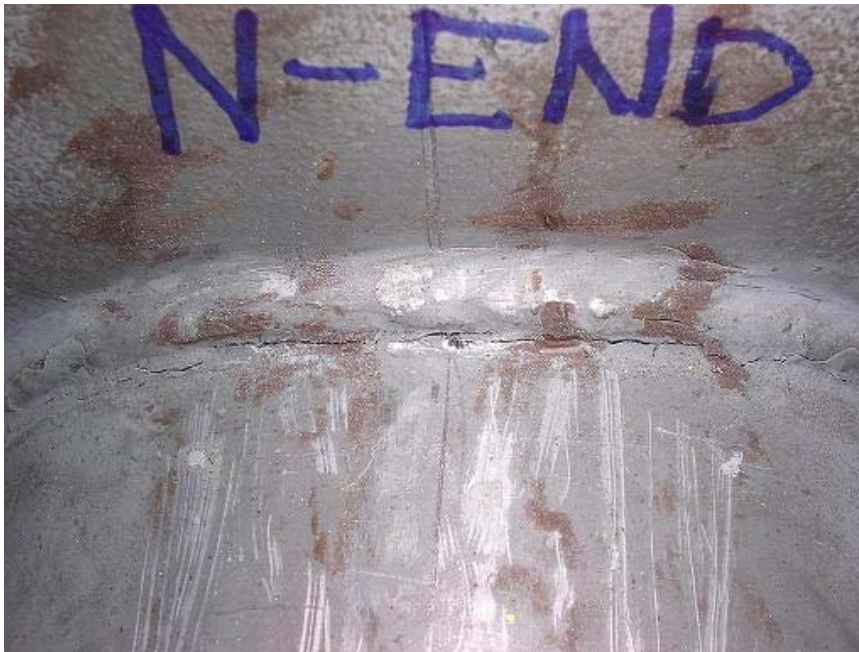
***Figure 8.3.1 Close-up of Fatigue Crack on Specimen DU Mast Arm Weld Toe
Along the UIT Application Line (90,680 cycles)***

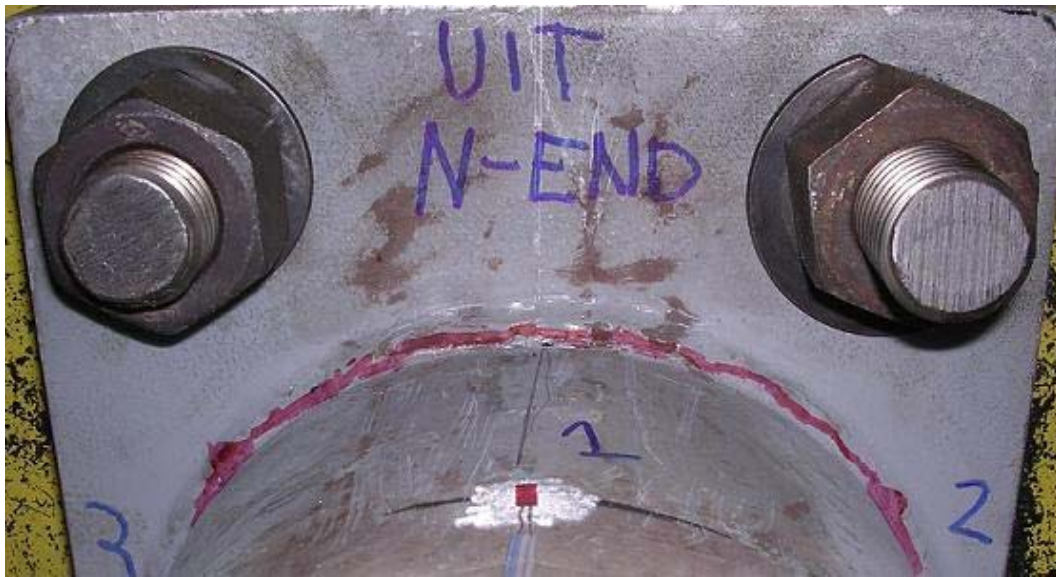
***Figure 8.3.2 Highlighted Fatigue Crack on Specimen DU Mast Arm Weld Toe
Along the UIT Application Line (90,680 cycles)***

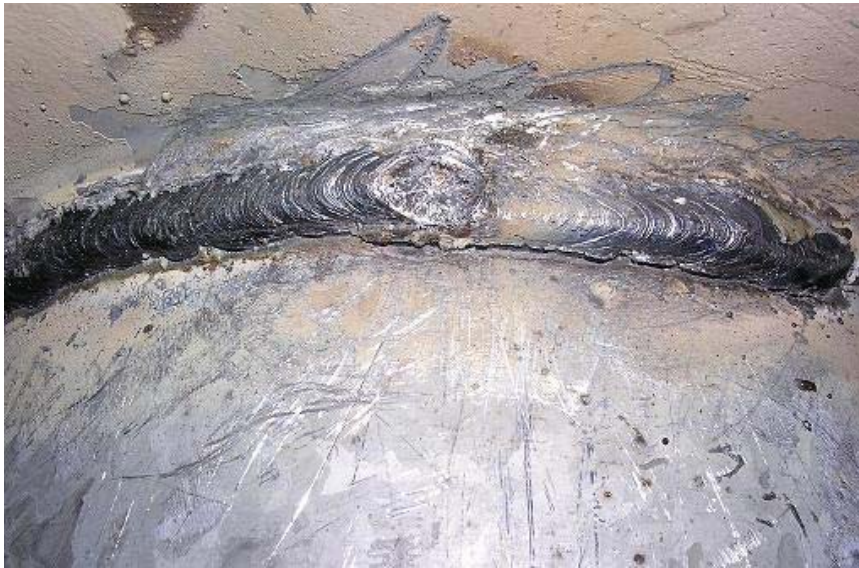
***Figure 8.3.3 Close-up of Fatigue Crack on Specimen DU Mast Arm Weld Toe
Along the Weld Repair (116,876 cycles)***

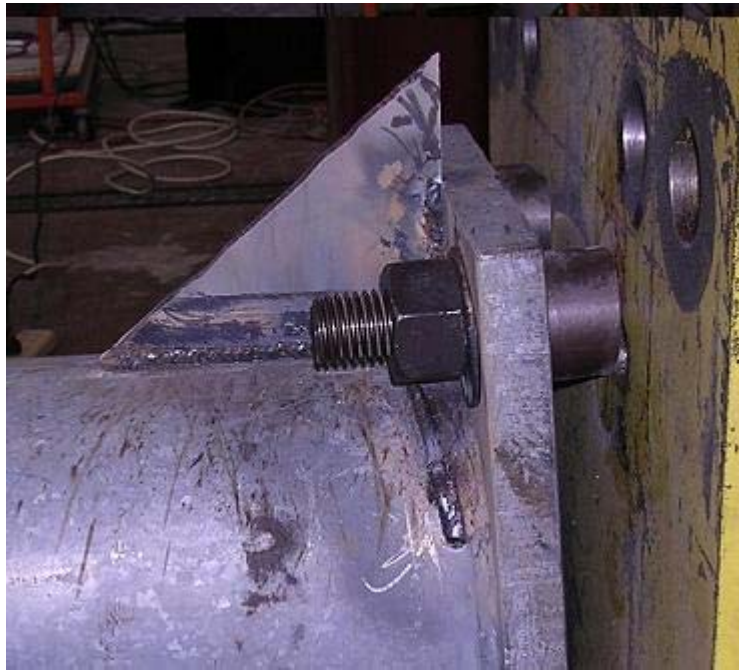
Figure 8.3.4 Stiffener Added to Mast Arm DU After 116,876 Cycles

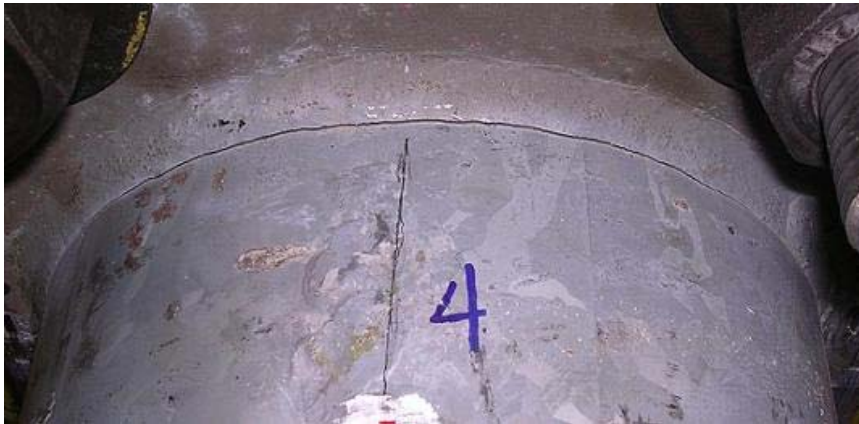
Figure 8.3.5 Close-up of Fatigue Crack Along Mast Arm Weld Toe of Specimen DN (224,905 cycles)

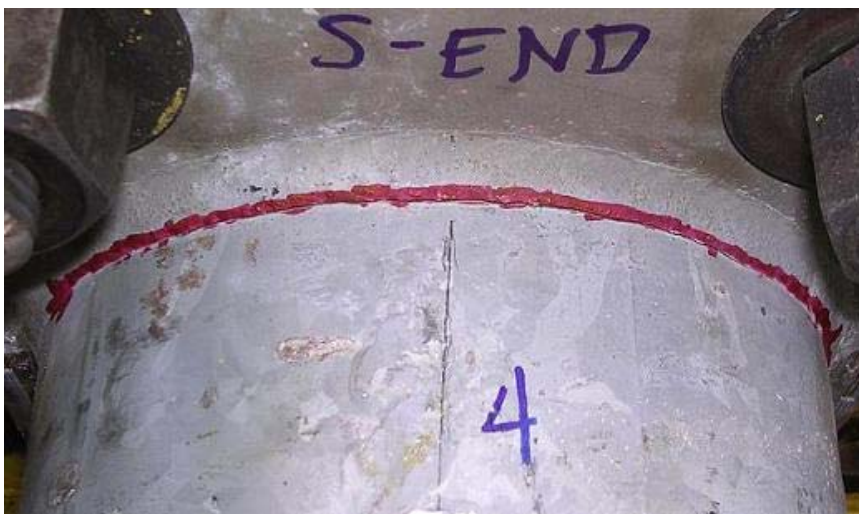
Figure 8.3.6 Highlighted Fatigue Crack Along Mast Arm Weld Toe of Specimen DN (224,905 cycles)

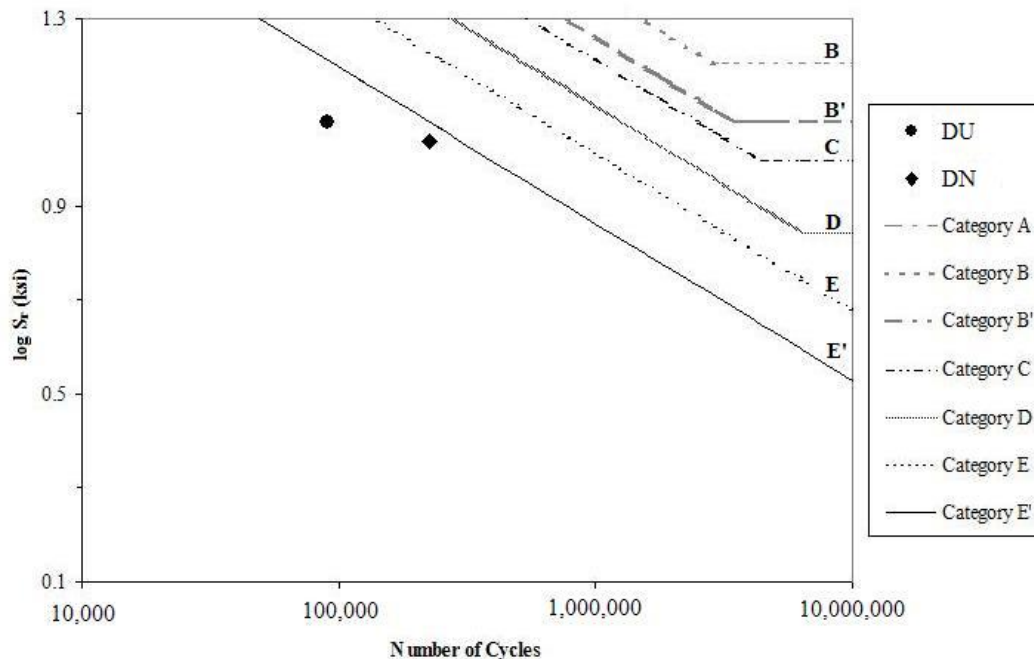
Figure 8.4.1 S-N Plot of DU, DN, and AASHTO Fatigue Categories

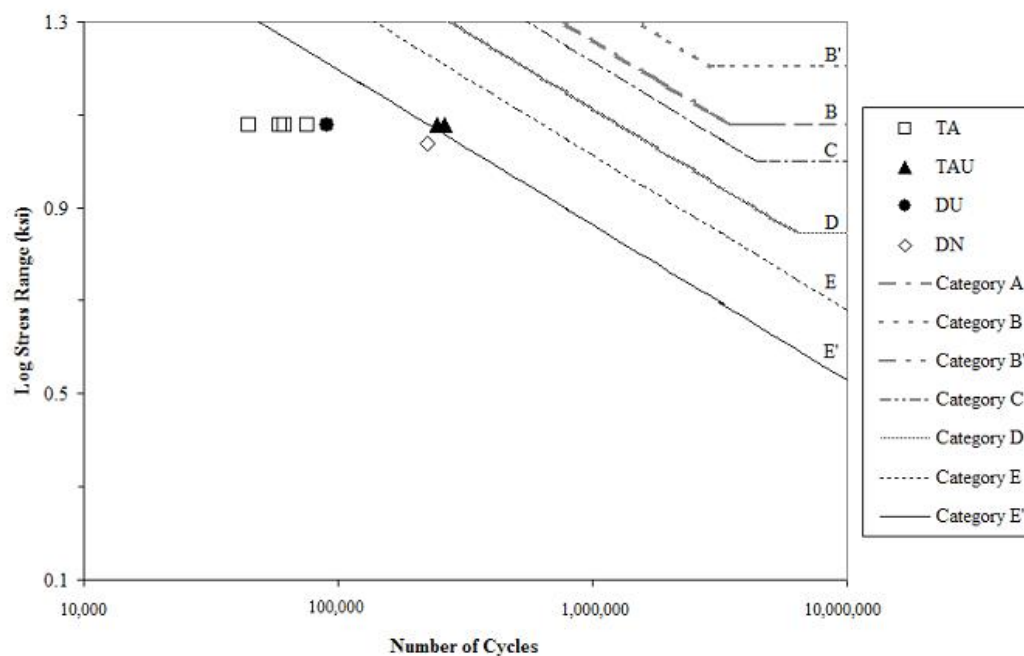
Figure 8.5.1 S-N Plot for DU, DN, and the TAU Series

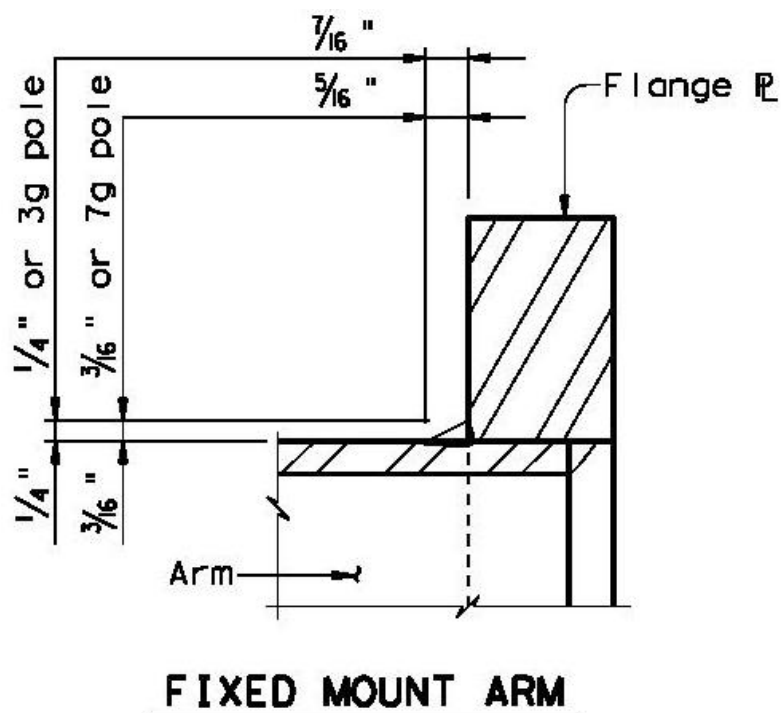
Figure 8.5.3.1 Standard Mast Arm-Baseplate Weld Dimensions from TxDOT Document MC-C-96

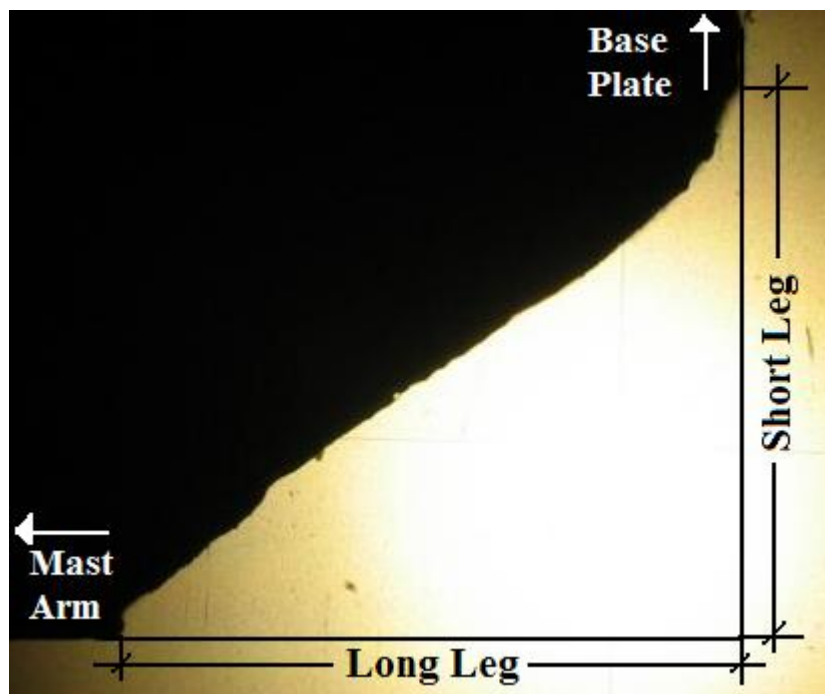
Figure 8.5.3.2 Typical Weld Leg Locations

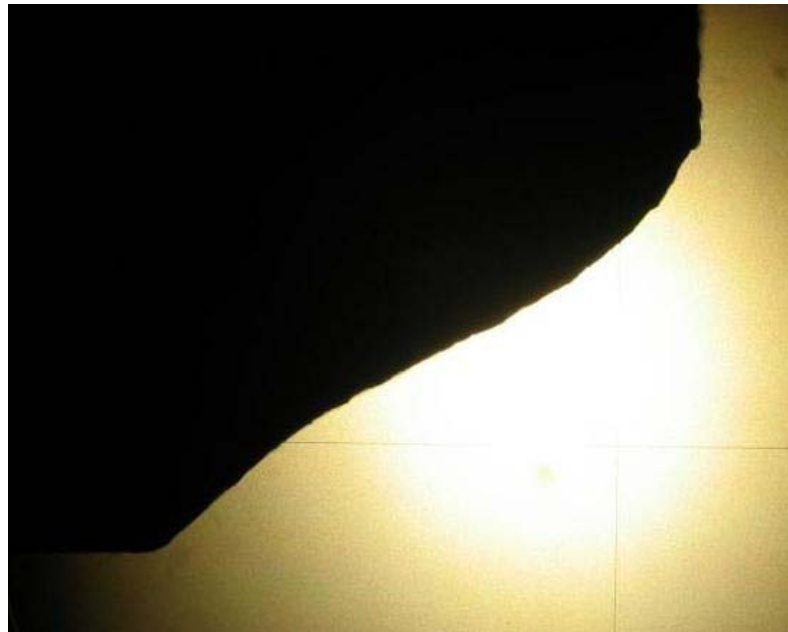
Figure 8.5.3.3 10x Magnification of Mast Arm Weld DU Before UIT

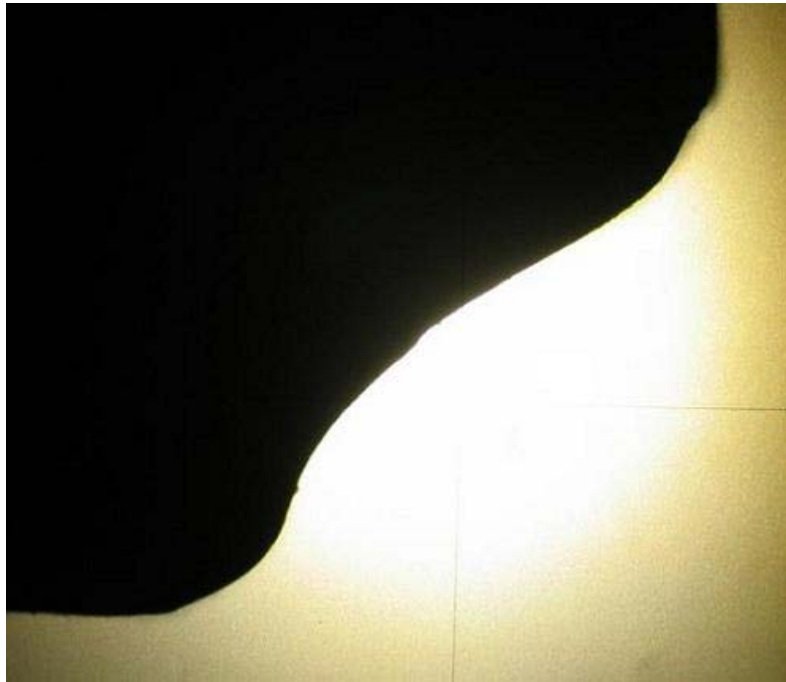
Figure 8.5.3.4 10x Magnification of Mast Arm DU Weld After UIT

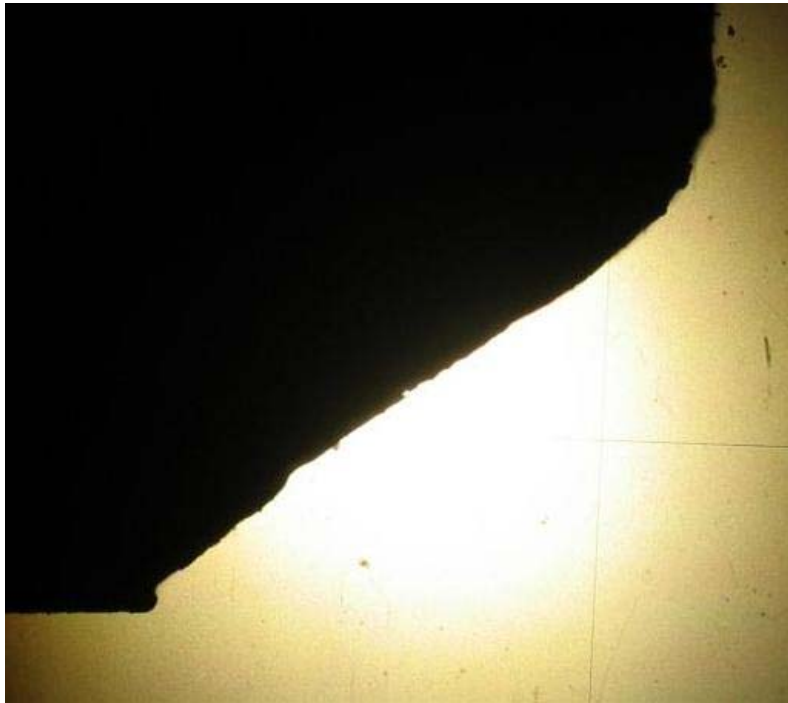
Figure 8.5.3.5 10x Magnification of Mast Arm DN

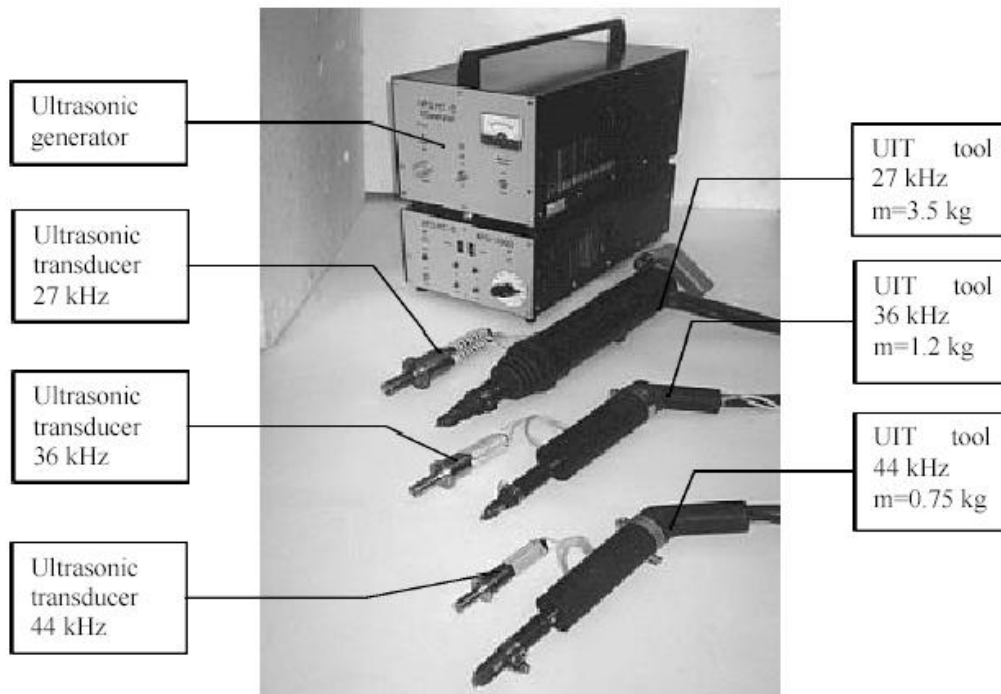
Figure B.2.1 UIT Equipment, Including UIT Generator, Transducer, and Tool

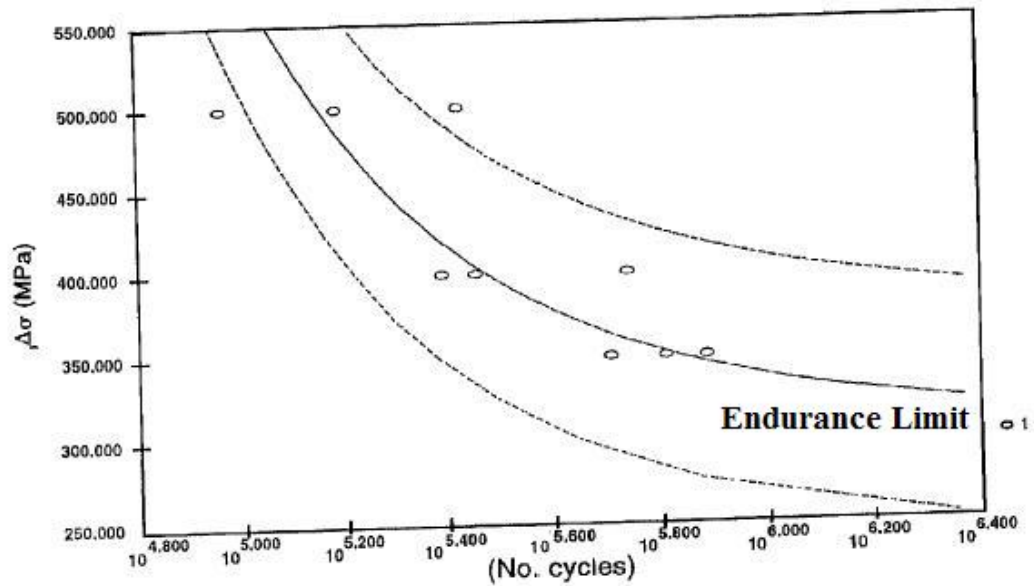
Figure C.2.1 Woehler's Curve; S-N Curve Showing Endurance Limit [10]

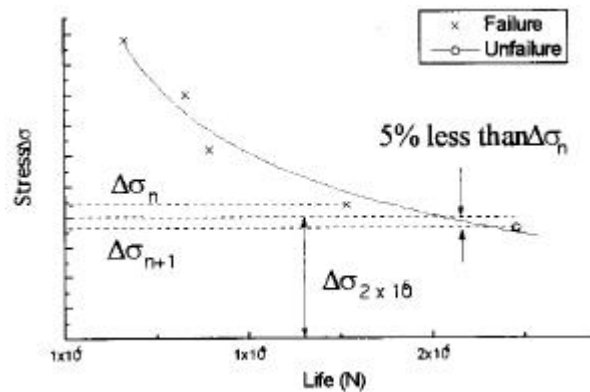
Figure C.2.2 Determination of Endurance Limit at 2×10^6 cycles [11]

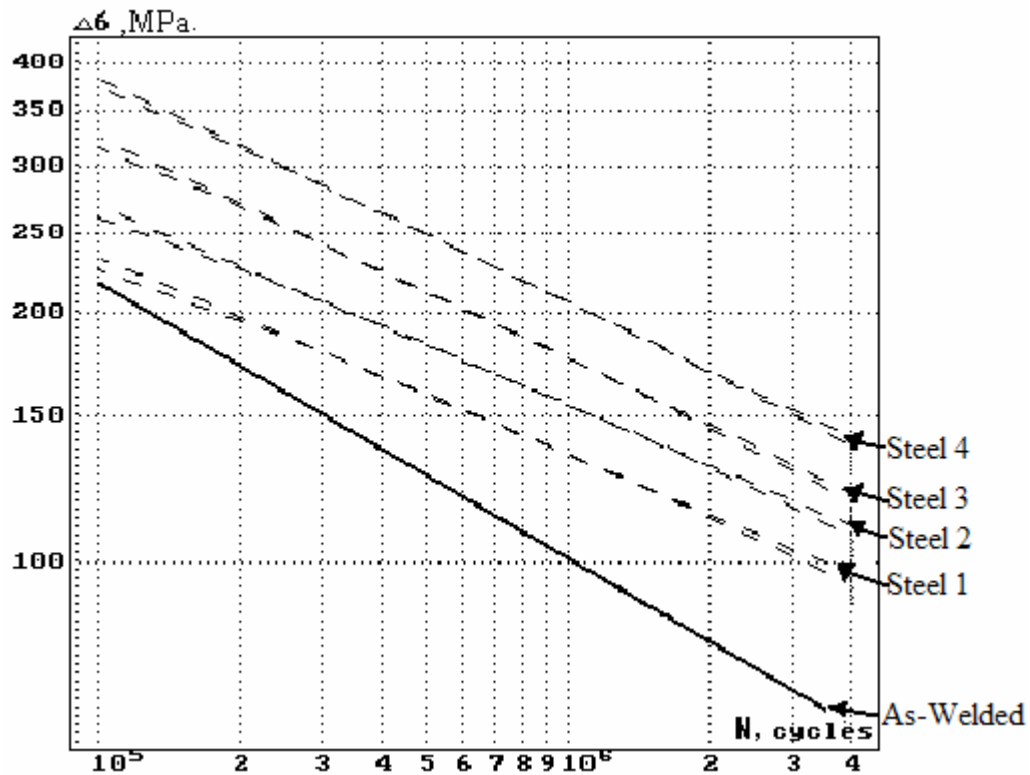
Figure C.5.1 Fatigue curves of non-load-carrying fillet welds. The solid line represents the as-welded condition for all steels, the dashed lines represent the 4 steels after UIT application [22]

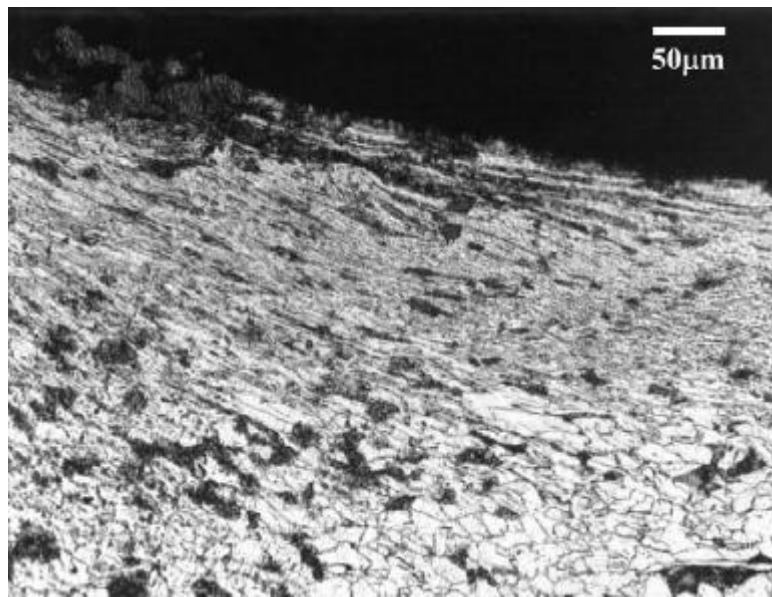
Figure D.4.3.1 Photomicrograph (200x) of UIT Application Area [15]

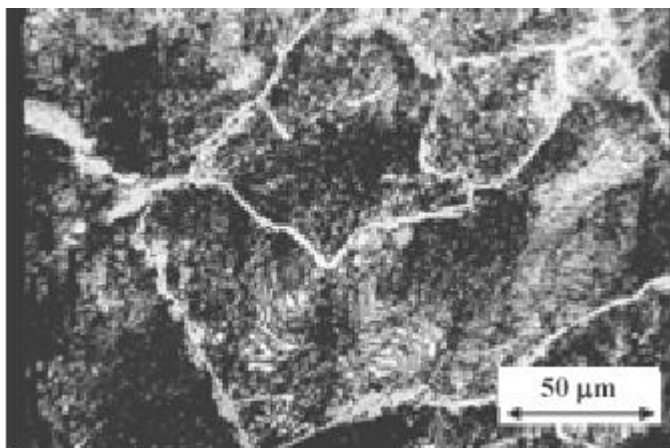
Figure D.4.4.1 Formation of Cementite Network After UIT Application [24]

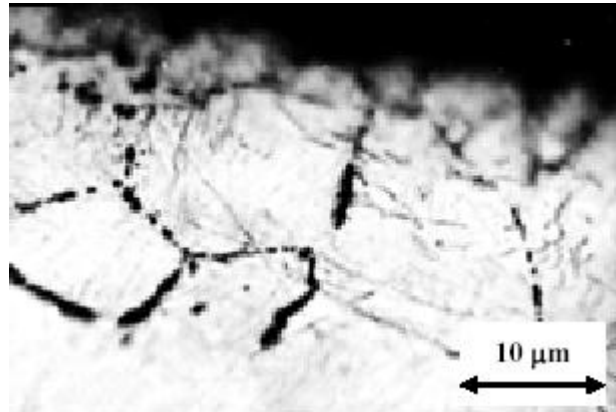
Figure D.4.4.2 Grain-Structure White Layer After UIT Application to Steel H3MA [24]

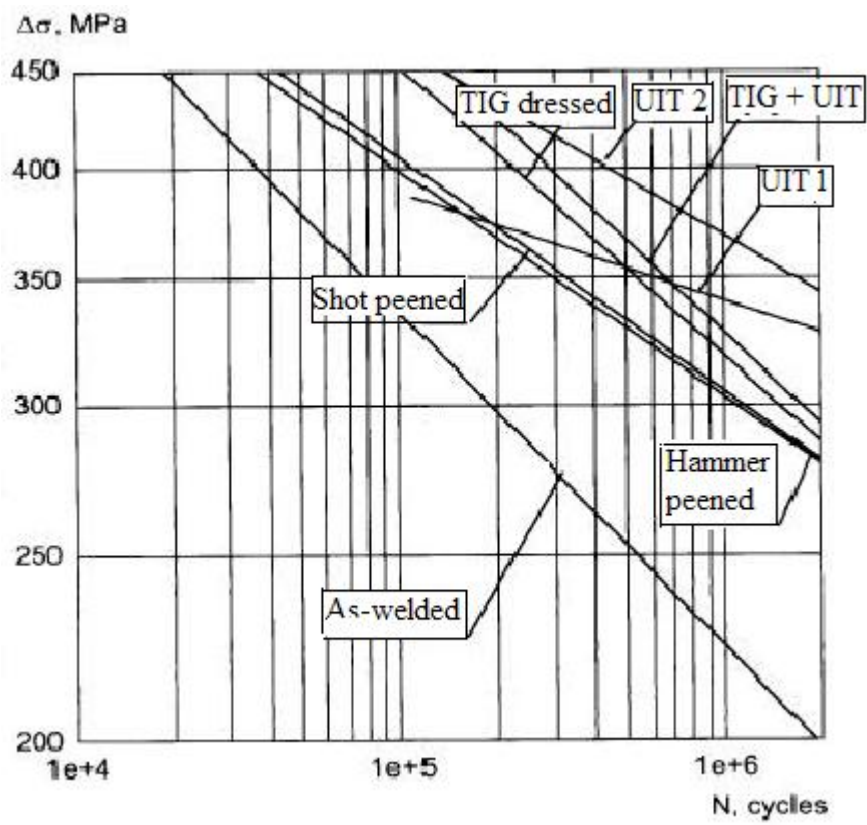
Figure E.1.1 Fatigue Curves for Weldox 420 Fillet Welds in the As-Welded and Improved Conditions [16]
