The Development of Roto Peening

A brief history on shot peening

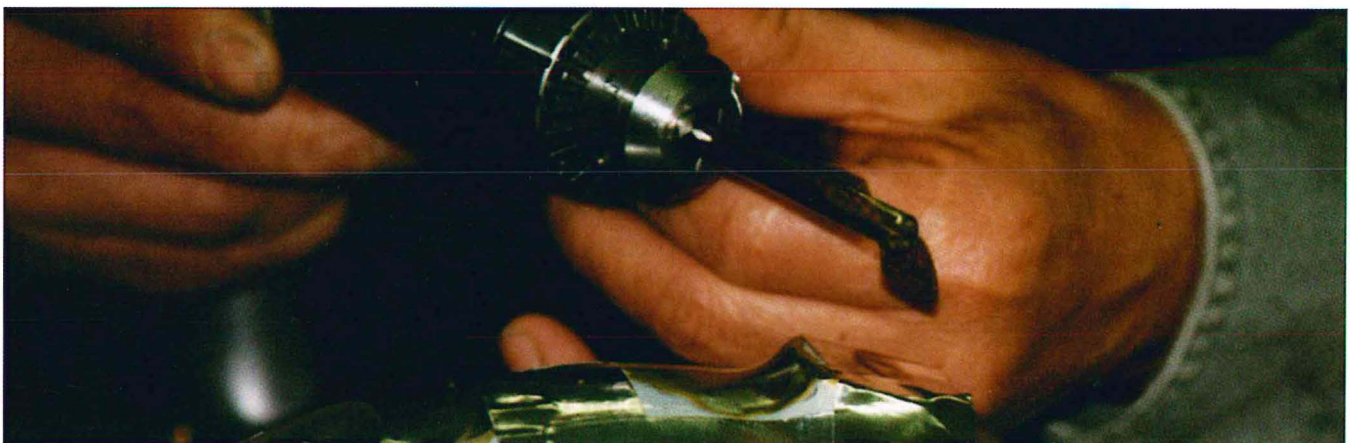
The 3M™ roto peen flap assembly TC330. Photo was taken during an Electronics Inc. roto peening training session at a military base. For more information on roto peening training, call EI at 1-800-832-5653 or (574)256-5001.

the 3M roto peen flap assembly TC330. Shot peening using TC330 consists of a slotted shaft mounted to a tool to which is attached flexible flaps on which shot particles are bonded. As the unit is rotated against the metal workpiece, the shot on the peening head impacts and peens the metal workpiece. The TC330 has a small footprint, is portable, and replaces free-flying shot. Because it is capable of repairing gouges, scrapes and corrosion in small and hard-to-reach areas, it was ideal for shot peening helicopter rotors.
