# Effect Of Shot Peening On Fatigue Behavior Of 7055-T77 Aluminum Alloy

Jilai, Ru (Metals & Chemistry Institute of China Railway Science Academy)  
Renzhi, Wang (Beijing Institute of Aeronautical Materials, China)

**Abstract:** The effect of shot peening on 7055-T77 aluminum alloy has been investigated. It has been shown that 7055-T77 aluminum alloy is a high strength alloy with microstructure of coarse grains and texture. This kind of microstructure can be greatly changed by shot peening. It is concluded that the improvement of fatigue property of the aluminum alloy can be achieved with the changes of microstructure and the introduction of compressive residual stresses due to shot peening. Moreover, a useful method, X ray radiography, was presented in this paper to measure the depth of plastic deformation layer of shot peening for the aluminum alloy with coarse grains and texture, which is very difficult to measure by means of regular X-ray stress diffractometer using successive material removal by electro-polishing.

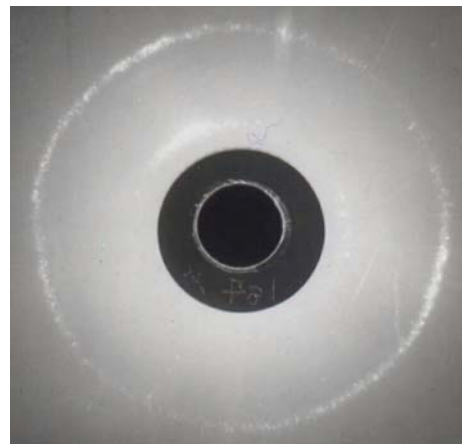
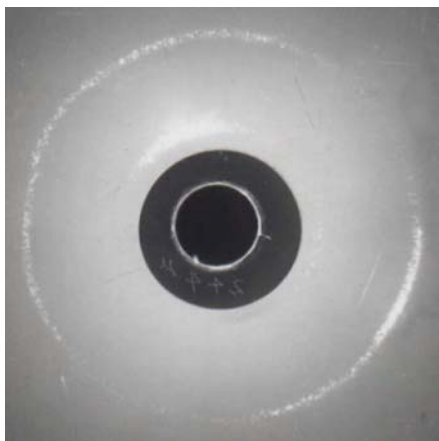
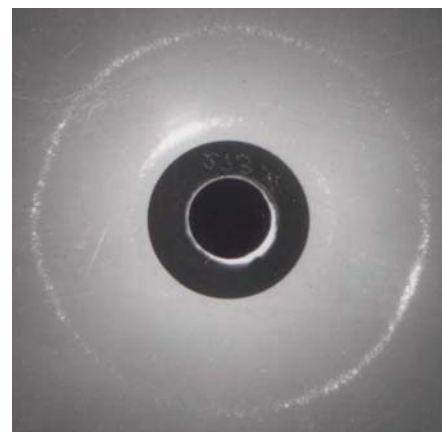
Fig. 1 Photos of X-ray back reflection patterns for unpeened and peened specimens

(a)—unpeened; (b)—peened ( $0 \mu\text{m}$ ); (c)—peened ( $12 \mu\text{m}$ );

- (d)—peened ( $26 \mu\text{m}$ ); (e)—peened ( $51 \mu\text{m}$ ); (f)—peened ( $75 \mu\text{m}$ );
- (g)—peened ( $89 \mu\text{m}$ ); (h)—peened ( $109 \mu\text{m}$ ); (i)—peened ( $132 \mu\text{m}$ );
- (j)—peened ( $184 \mu\text{m}$ ); (k)—peened ( $244 \mu\text{m}$ ); (l)—peened ( $273 \mu\text{m}$ )

However, great changes have taken place from discontinuous and spotted diffraction rings (Fig. 1a) of the unpeened specimen into continuous diffraction rings without spots (Fig. 1b) due to shot peening. The main reasons resulting in the difference of diffraction patterns are coming from the increase of lattice distortion and the fine subgrains in the deformed surface because of shot peening. With the increasing depth of deformed layer, the diffraction patterns of the peened specimen changed gradually. For the depth of  $0\text{-}26 \mu\text{m}$  (Fig. 1 b-d), the diffraction rings are getting weaker with the increase of the deformed depth but there is no appearance of diffraction spots and texture. Therefore, X-ray stress diffractometer may be employed to measure parameters of deformed layer due to shot peening. The parameters include residual stresses and half widths that reflect the changes of lattice distortion ( $\Delta a/a$ ,  $a$ - lattice constant) and the size of subgrains. According to the experiment (Table. 4), the depth in which X-ray stress diffractometer can be used to measure residual stresses and half widths is as far as  $30 \mu\text{m}$ . For the depth of  $51\text{-}89 \mu\text{m}$  (Fig. 1 e-g), texture appeared in the diffraction rings but no diffraction spots was found. At the depth of  $109 \mu\text{m}$  (Fig. 1 h), diffraction spots appeared obviously on the background of the rings. With the depth further increasing, the background of the rings is getting disappeared and diffraction spots are getting more and more. When the depth is  $273 \mu\text{m}$  (Fig. 1 l). The diffraction patterns is as almost the same as that of unpeened specimen (Fig. 1 a). In this way, the depth of the deformed layer due to shot peening was determined which is about  $273 \mu\text{m}$ .
