The Ultimate Strip Mix-Up

A customer called Electronics Inc. (EI) and was very upset. "Your strips from lot 76547/1-23 aren't conforming to their N1-SS designation," he said. "We want them replaced." N1-SS strips are 100% inspected for prebrow to ± 0.0003 " and are used in the most demanding aerospace applications. The following are results from the Failure Analysis conducted by EI's Operations Manager. The analysis uncovered multiple problems when the strips, recovered from the customer's worksite, were inspected.

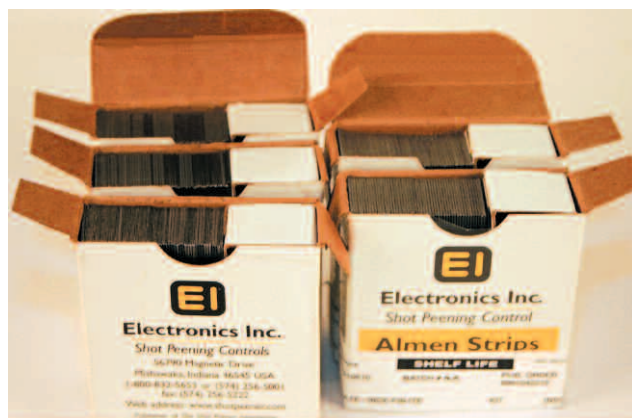
Figure 1. The box on the left holds the newer EI strips and the "earlier" EI strips. The ends of the earlier EI strips are darker due to a different heat treatment.

Before 2007, EI didn't manufacture their own strips—for the sake of simplicity, they will be called "earlier" EI strips. A visual inspection showed that earlier EI strips had been mixed with newer EI strips in some of the boxes. The earlier EI strips were darker due to a different heat treatment and they had oil stains. (Figures 1 and 2). Dark coloration and oil stains aren't defects, just an indicator of a different manufacturing method. Also, some of the boxes had an older package design that EI hasn't used for several years and these were clearly marked with lot number B55294B-08 and a N1-S grade.

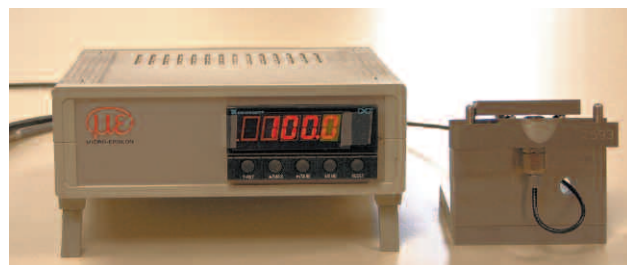
Figure 3. An EI "super" gage with .01000" certified step block. EI has two super gages that measure prebrow to a resolution of 0.00001" and meet SAE J 442 and AMS 2430 for #2 Almen gages. The readings from the gages are continually compared and monitored for accuracy.

The newer EI strips were measured for compliance to the N1-SS prebrow specification (0.0003") on the EI Super Gage (Figure 3). The Super Gage has a resolution of 0.00001", compared to a TSP-3 Almen gage which has a resolution of 0.00005". EI has two Super Gages and two gage operators, and the readings from the instruments are

compared and monitored. For additional verification, the prebrow of the strips was measured on a TSP-3 and the results were the same: All of the new EI strips were within N1-SS specification.
