New CUT-WIRE

Big Boon

By H. H. Miller

Research Metallurgist,
Buick Motor Division,
GENERAL MOTORS CORP.

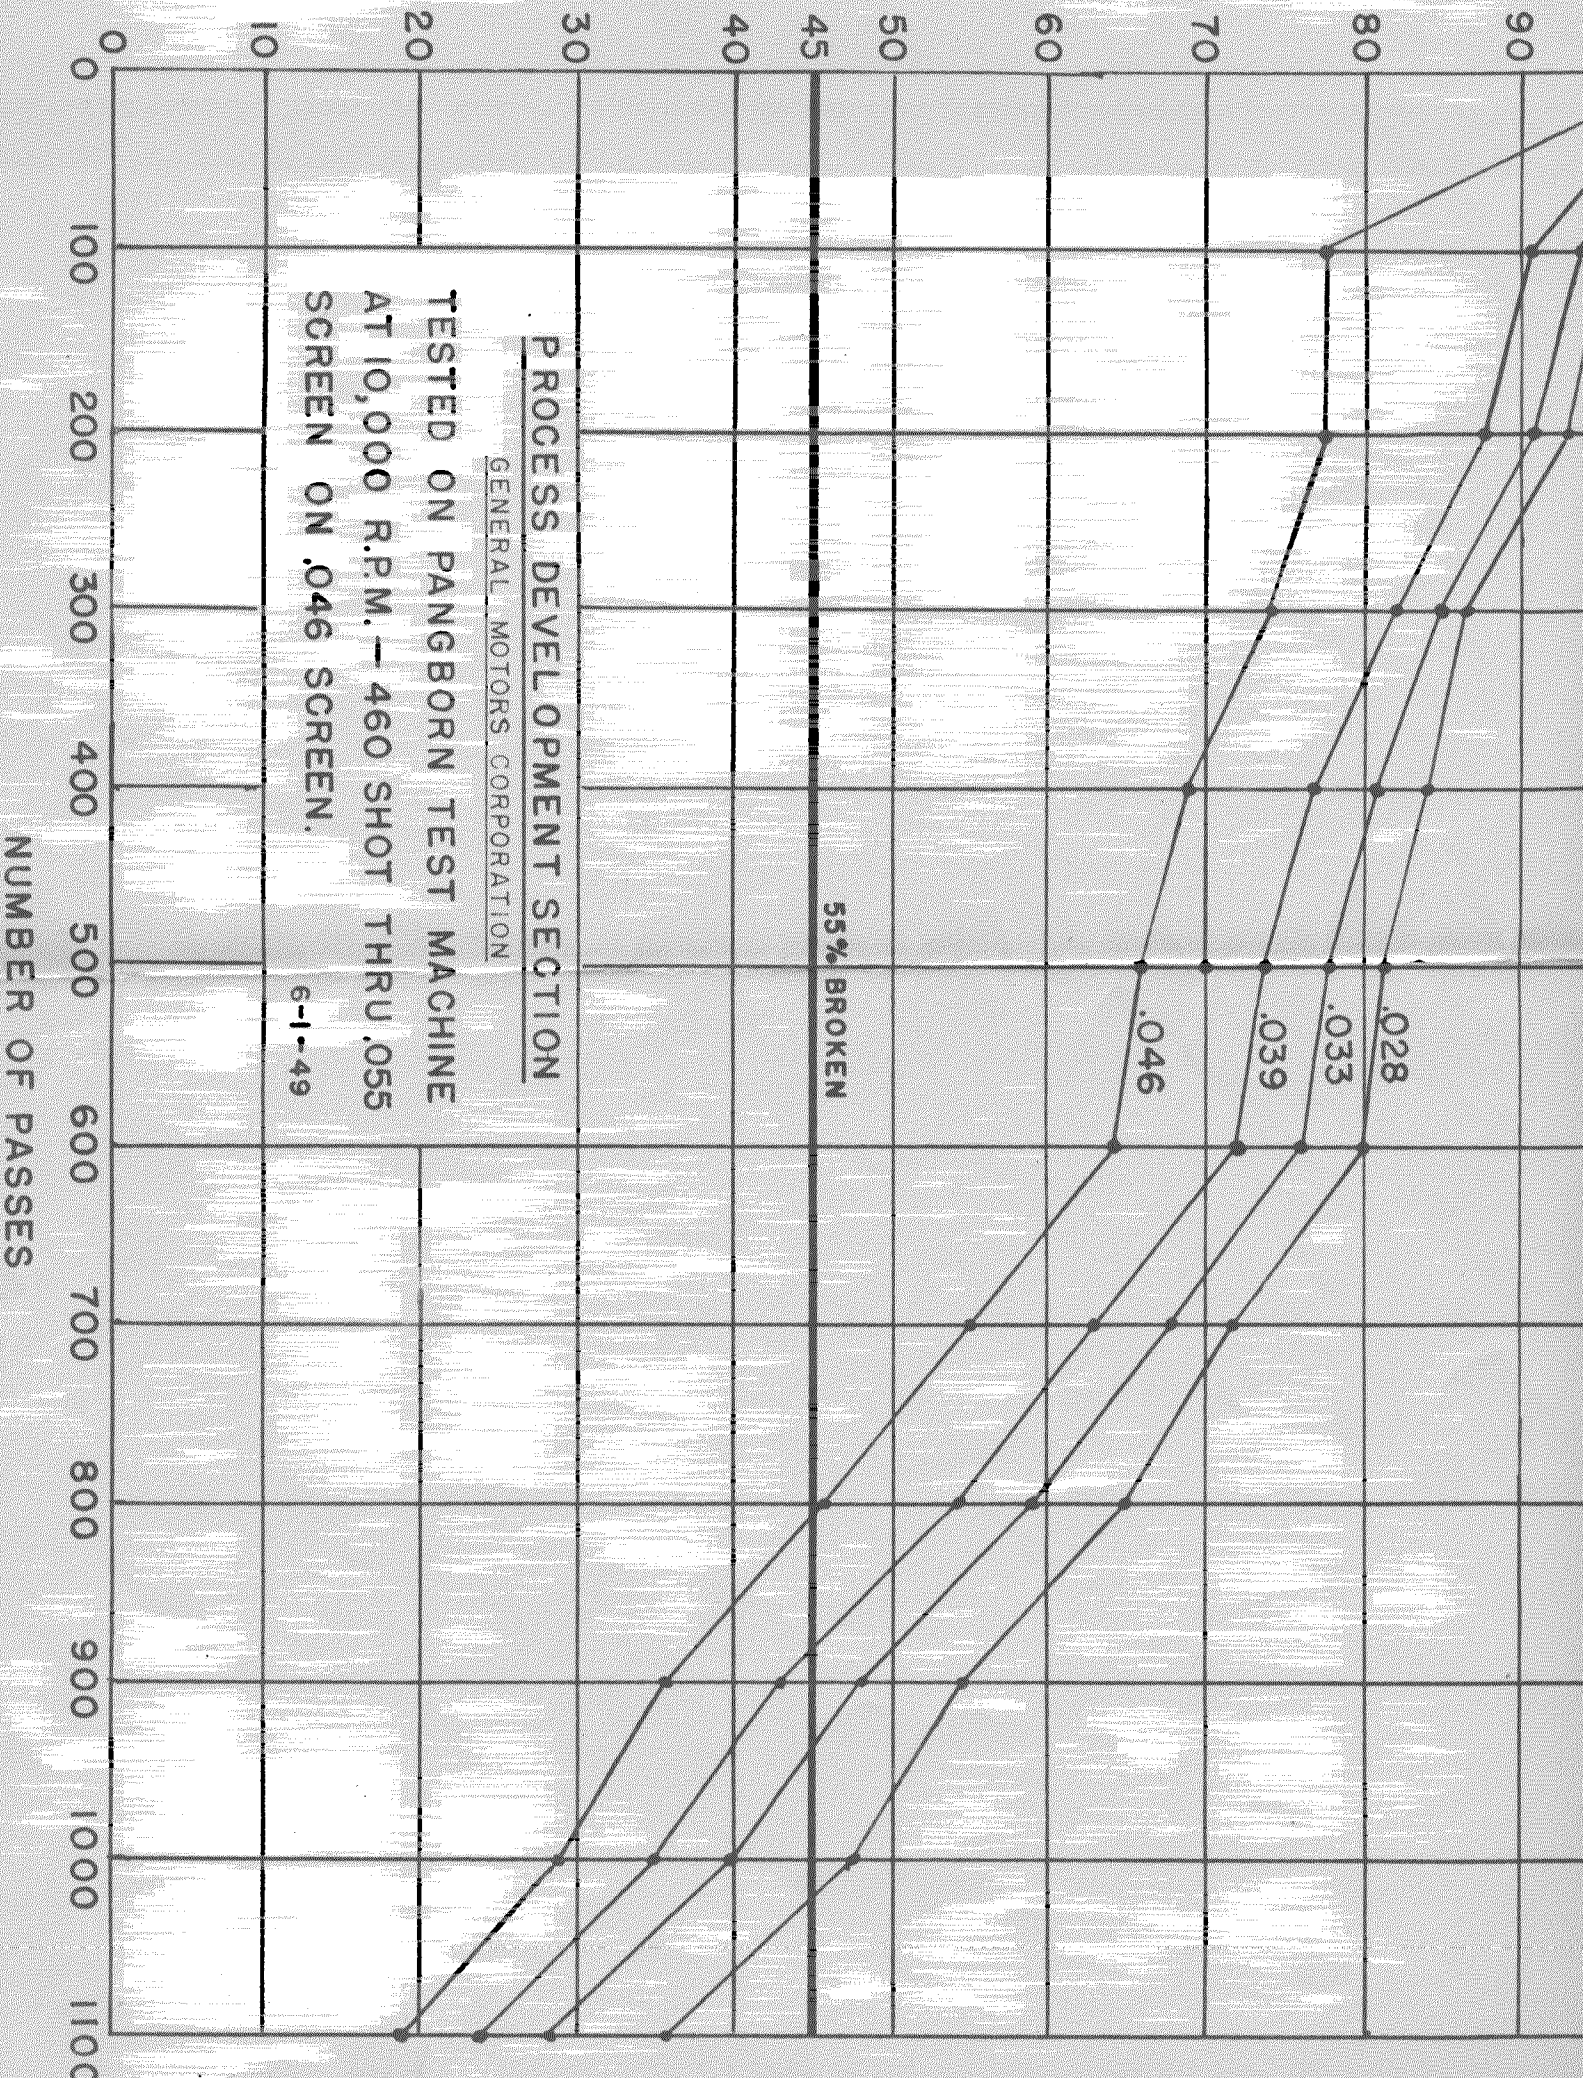
.028\"
SCREEN

GOOD SHOT IN PERCENT

The size was found to remain uniform throughout the 80-day period charted and the size is stabilized from the seventh day on. The amount of shot added to the machine each day after the tenth was 100 lb. Screen analysis showed that an average of 80% of the material being delivered to the wheel is maintained on the 0.033-in. screen. About 15% is retained on the 0.028-in. screen, and more than 98% is retained on the 0.033, 0.028, and 0.023-in. screens.
