Shot Peening Comes Along for the Ride

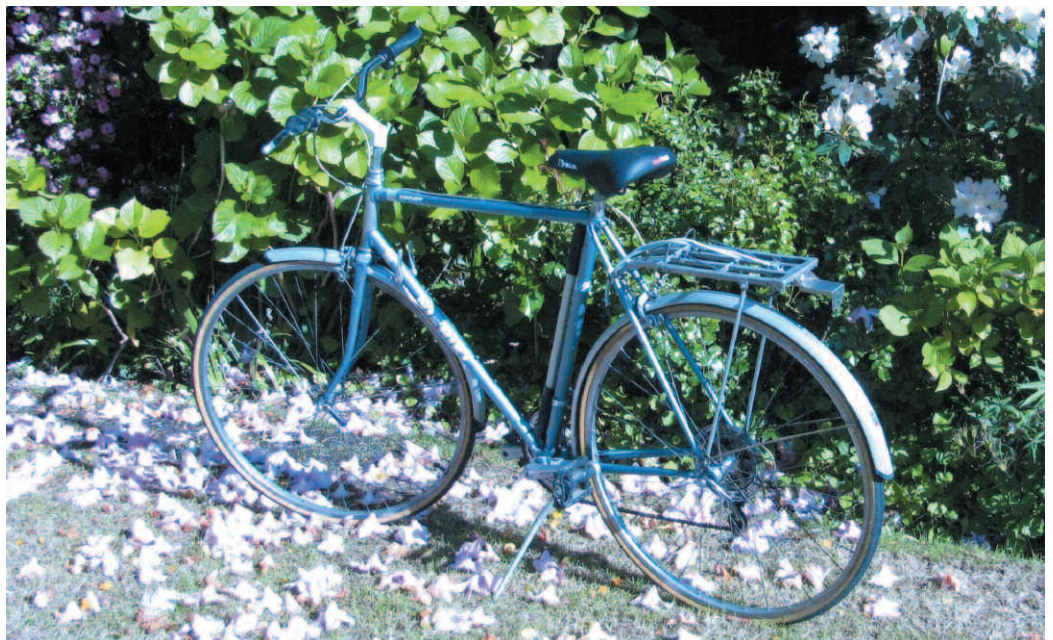
Above: David Thomas enjoys riding his bike to his job as the Technical Instructor/Engineering Training for Air New Zealand. Left: One of Dave's bike spokes that was peened with glass beads.

"I teach roto peening and shot peening so I knew that the failure was primarily due to the tension stresses in the bend area, leading to fatigue failure," said

David. He decided to get the spokes peened with glass bead. "I can report that since peening the spokes, no further failures have occurred. I take the same route every day so conditions have remained the same. Glass bead peening of the spokes provided a 100% improvement in reliability. I am on the lookout for further uses for the mechanical pre-stressing to add durability to other components," he added.
